Town of Londonderry CIP Committee
268B Mammoth Road - Moose Hill Council Chambers
AGENDA
August 11, 2025
6:30 PM

Historic Building Conditions Assessment

Reverend William Morrison Meeting House
Londonderry, NH

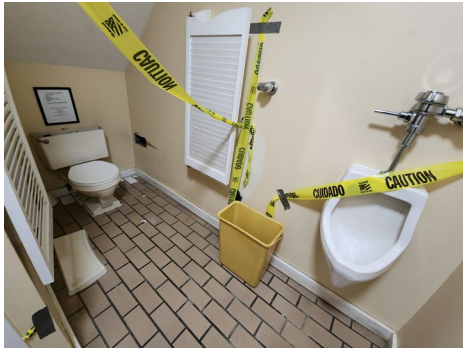
4.5: The men's bathroom under the stair is not ADA accessible, and has a saloon style stall.

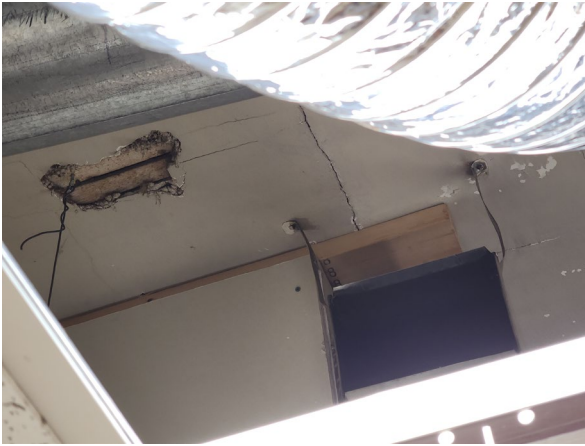
5: The kitchen is VCT 12x12 flooring, possibly c. 1980s plastic laminate. The countertops are chipped, warped, and crooked. The ceiling tiles are not in poor condition however, there is approx. 4-5' above the ACT ceiling, up to the original ceiling, which is lath on plaster. Some of the plaster is missing, and the lath on plaster that remains is terribly cracked. ACT ceiling has 2x4 lights. There is a small hot water tank underneath the microwave next to the window that is roughly 10 gallons.

5: Kitchen: Finishes are worn throughout, some in poor condition – especially the ceiling. See #3 above for Kitchen relocation suggestion.

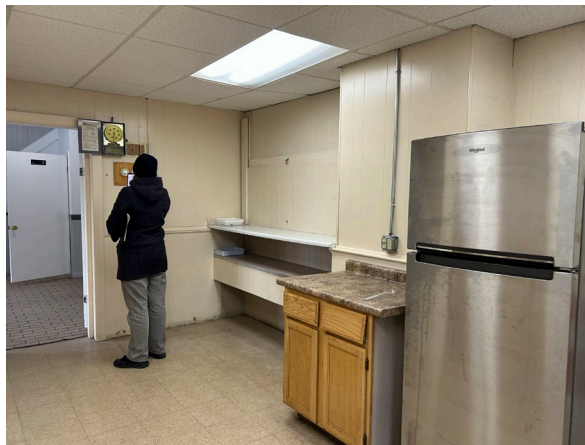
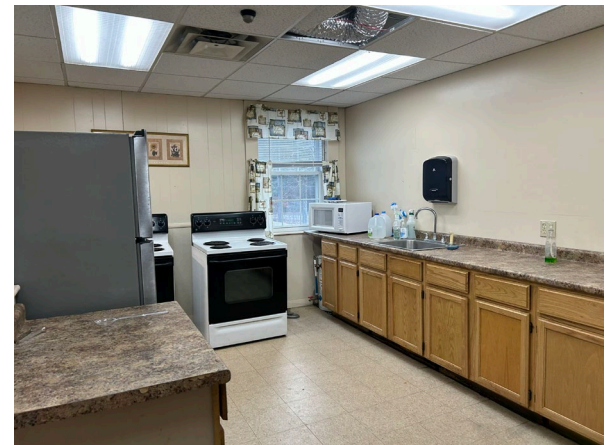
There is a refrigerator, fire extinguisher, surface mounted conduits, two quadruplex receptacle outlets, 70's era wood paneling, which has been painted on the walls. On the wall next to the door is a Dayton seven day dial, time switch, four pole, two normally open, two normally closed, and model number 2E21. The paneling seems original before paint.

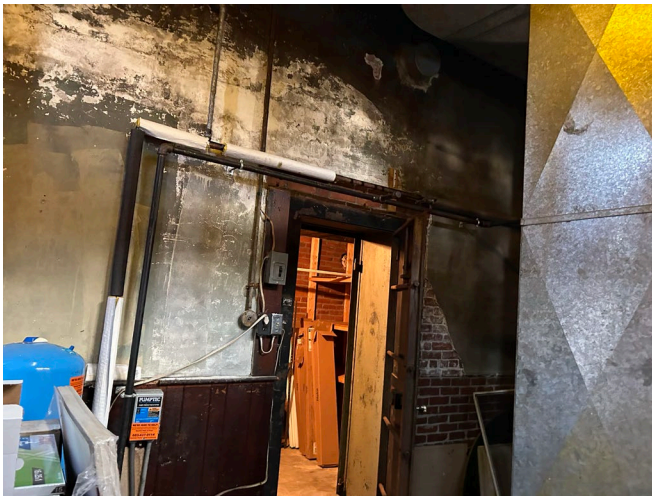
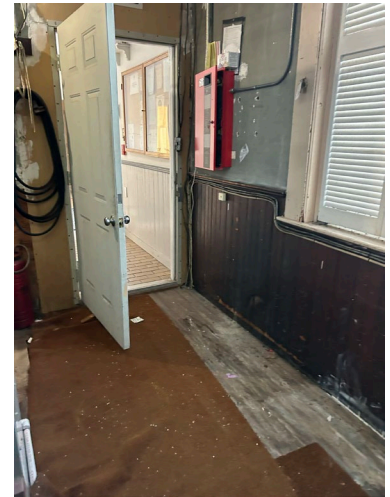
6: The boiler room has period beaded wood paneling below the chair rail and plaster on lath above, which are in worn condition. There are modern, bi-fold, wood interior shutters. The windows are Harvey vinyl, double hung, double glazed with grills between the glass, with no screen or storm windows, installed in 2005. There is a vault behind the furnace powered by gas. Behind the furnace is a pressurized expansion tank installed in 2006 that feeds the furnace.

6: Boiler room - See item #24 below for HVAC system. Wall finishes are worn but historic and would benefit from some repair and repainting.

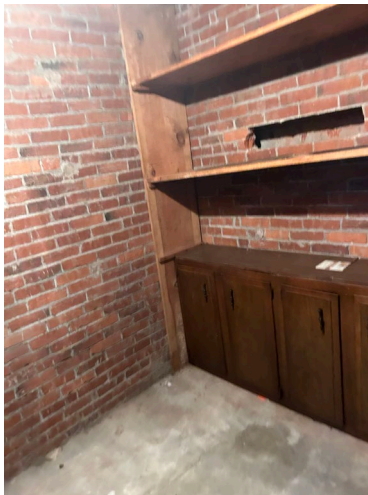
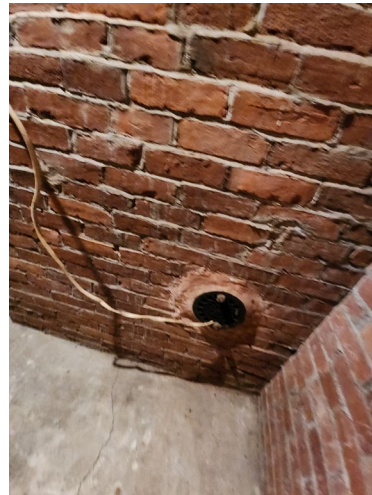
7: The Vault is a MacNeil with an urban steel door. It's secured into a very thick, 2' thick wall of brick and or concrete covered in brick. The wall between the vault and the auditorium is a cavity wall with two layers of brick and a 4" gap in the middle, which is unusual for this type of construction. The ceiling is wood with plaster and possibly brick above as well for safe keeping of whatever used to be in here. There's a very small vent in one corner.

7: Vault: This space is historic, no work other than general cleaning and maintenance is recommended.

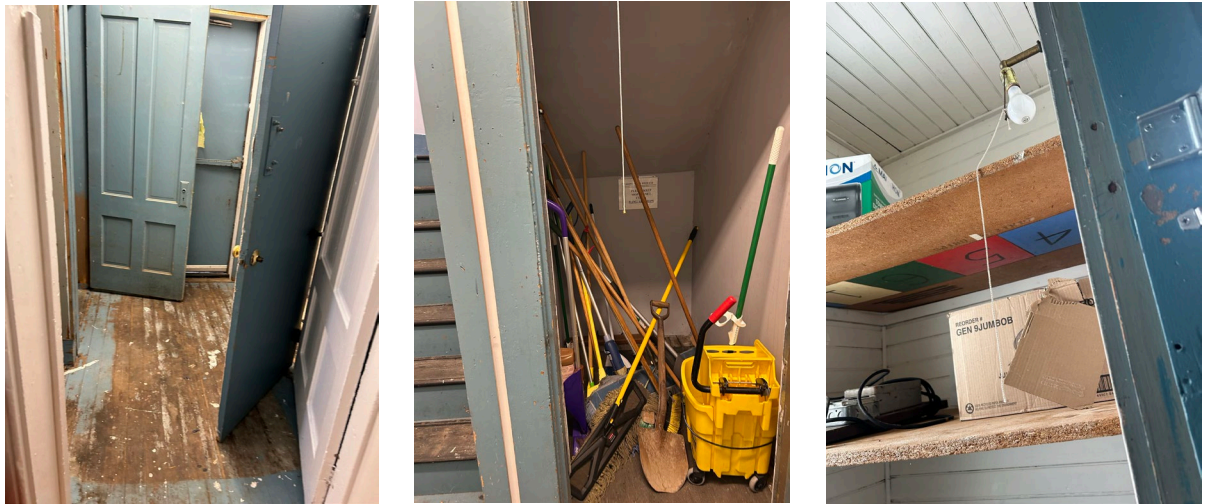
9: The front stair hall has very worn paint, painted flat wood trim, and drywall in very poor condition. There is broom storage underneath the stair and rubber treads at the mid landing, as well as another small closet with some shelves and a painted beadboard interior. There is only one handrail at each side of the stairwell landing. The door at the bottom of the stair goes outside to the south parking lot and has a narrow, 30", c. 1950's panic bar. The frame is worn, rotted, poorly insulated, and in overall poor condition. The door to the kitchen is an old hollow core door, in poor condition, with a broken door knob. The door into the main auditorium does appear of an older vintage, with partially missing late 19th century door hardware and flat stock trim.

- a. Replace or repair the very worn finishes at walls, ceiling and treads.
- b. Install handrail on the side without a handrail.
- c. Replace the worn door at the bottom of the stair exiting to exterior with a wider (36") code compliant door and hardware.
- d. Replace door between fire stair and auditorium with a wider (36") 45 minute fire rated door and code compliant exit hardware.
- e. Closets and storage within a fire exit stair are prohibited and should be removed.

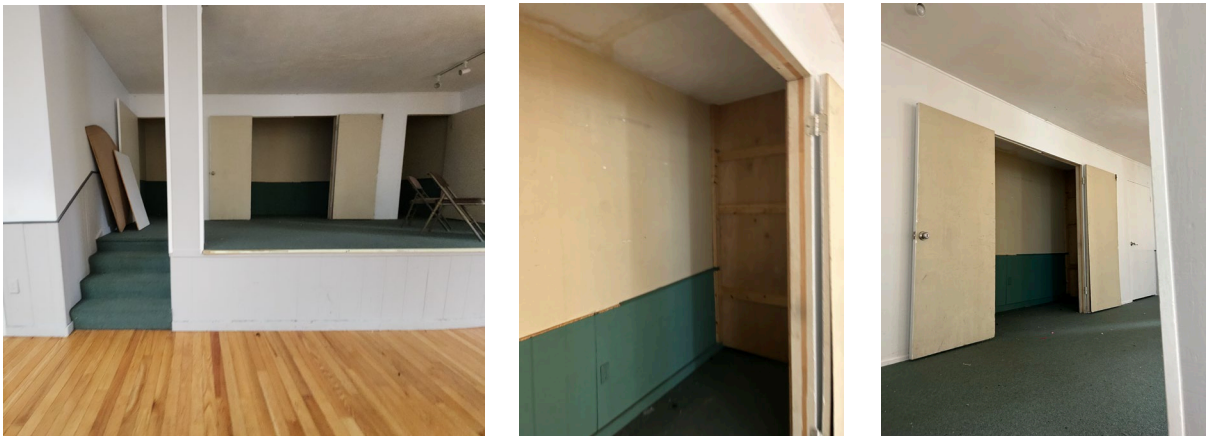
10 & 11: The exit door from the stage to the outside has very old panic hardware and closer, and is in need of refurbishment. There's an exit sign above, emergency lighting, fire alarm, station, fire extinguisher. There is a stage platform with steps on either side, which has c. 1980s paneling, textured plaster, ceiling on drywall. There is some circa 1980's track lighting, and worn green carpeting in poor condition. There is another 100 amp electrical panel, stage left, which is not labeled.

There does appear to be some water damage at the ceiling above the stage that worsens when inside of the closet behind the stage. The height of the stage platform is 32" above the auditorium and there are no proper handrails.

- a. The exit door from the stage to the exterior requires weatherstripping and new code compliant exit hardware.
- b. Stage finishes and lighting are not historically significant, they are functional but worn, and would benefit from updates.
- c. Repair ceiling and roof flashing at location of visible water damage above the stage and backstage
- d. Handrails should be installed at the side stage steps.

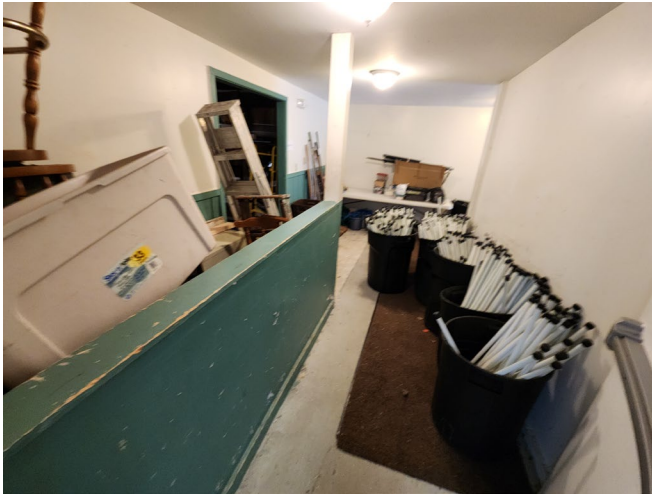
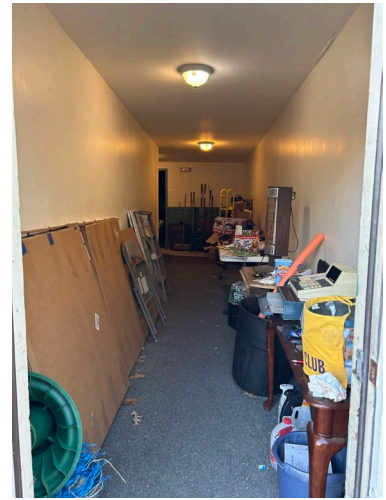
12: The storage behind the auditorium is the current ADA access to the building as the floor is ramped however there is storage obstructing the pathway. It ramps from the auditorium to the back hallway in an ell, until you reach the door to the parking lot.

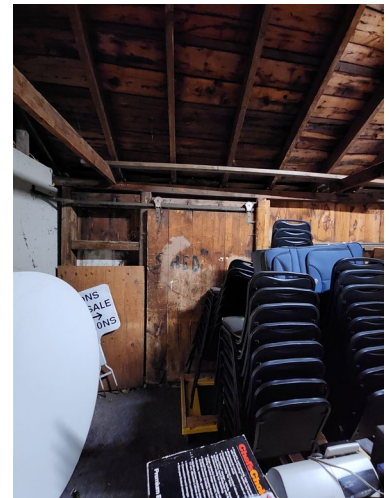
13: The storage shed addition is framed with 2x6 lumber. There's no ridge plate or ridge beam and appears to be approximately 100 years old or more, but not post and beam. The floor has carpet and is not level. There's a sliding track barn door on one side, the wall sheathing shows quite a bit of moisture intrusion, as does the roofing boards, which have been splintered and there are gaps, but it appears to have been covered with new roofing to keep the water out currently. The old siding is evident in the attic, above the connector, behind the stage in the shed.

- a. The tops of walls and roof framing show some sagging, reference attached *Structural Assessment report*.
- b. Wall and roof sheathing shows signs of past moisture damage. Inspect and repair roofing and flashing in this area.
- c. If this area is to be occupied for programmed space (such as a relocated kitchen), insulation, interior finishes, doors, and MEP will be required.

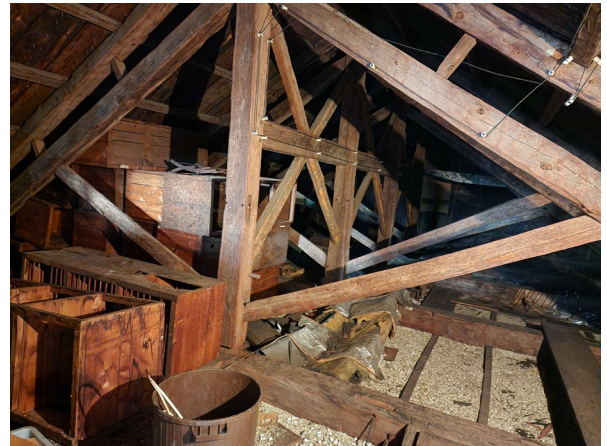
15: The attic above the main hall has blown in insulation at the attic floor, and cellulose. There is old knob and tube wiring throughout, and no sprinkler system. RE: Structural report

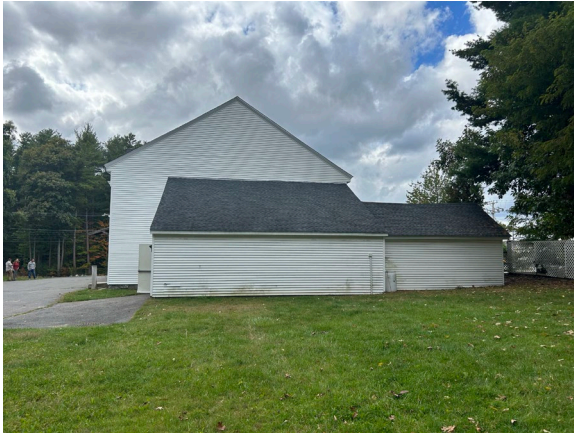
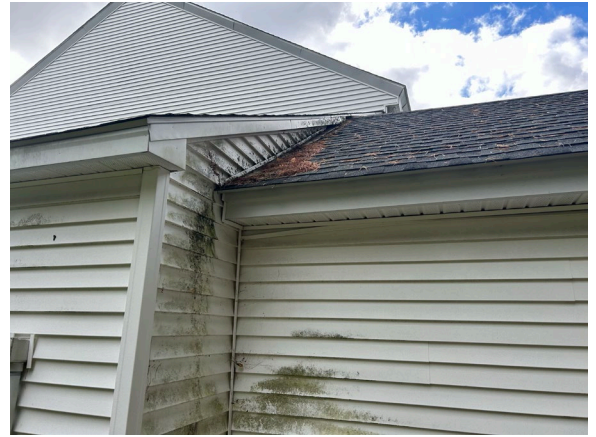
18. Eastern Façade:

The eastern façade has siding in very poor condition. The foundation is less exposed and in areas where it is exposed it looks in decent condition. The back corner of the building connection to the shed has some severe runoff and warping that may need some selective demo in order to investigate if there is moisture damage underneath, and the underside of the roof is also worn. The siding to the shed addition needs to be cleaned and has some minor cracks, the wood underneath appears not too bad.

- a. The back corner of the main building at connection to shed shows signs of moisture damage at wall and soffits from roof water runoff. Localized removal of siding and trim is recommended to determine extent of damage and repair needed in this area.
- b. The siding at shed addition needs to be cleaned, minor cracks should be repaired.

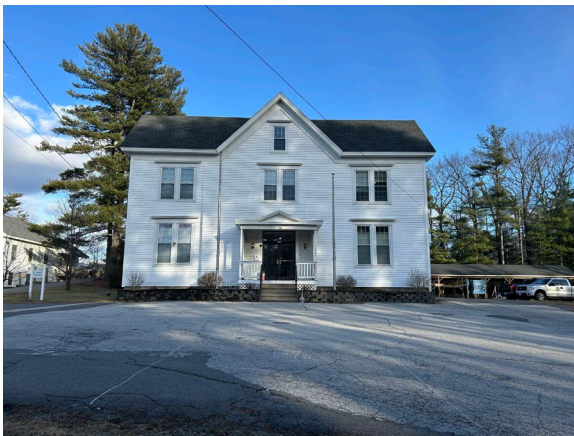
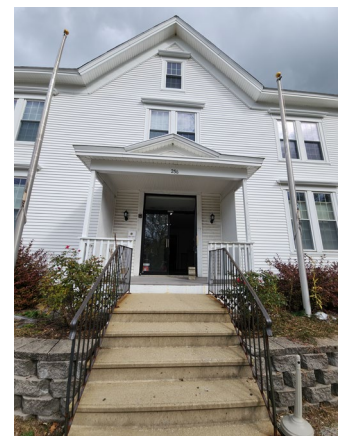
19. Western Façade:

The front porch's paint is chipped, the underside of the roof eaves look in good condition, though there is some minor damage on the front roof eave but not too severe. Some of the siding is cracked and the foundation's mortar looks like it's in need of some repair. The wood appears to be mostly sound, there is minor damage and it's in need of cleaning. Some of the siding at the front door siding is also chipped and peeling. The wood itself at the bottom of the door frame is very worn, and there is some cracking to the wood, but not too severe. There is some cracking at the wood on the left side of the porch floor support, the front left column. The mortar on the front left side also needs to be repaired. The windows are in good condition. 39" height to front entry

- a. Portico needs repainting.
- b. Repair minor damage on front roof eave
- c. Repair minor cracks in siding and wood trim, clean and repaint as required.
- d. The wood at the bottom of the door frame needs repair.
- e. Repair cracked wood on front left portico post.
- f. Reference *Structural Assessment Report* for foundations.

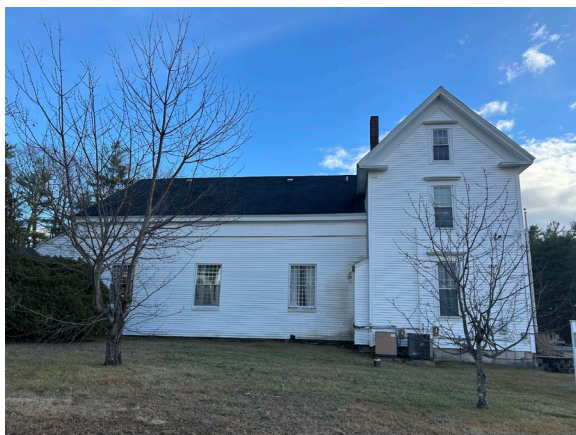
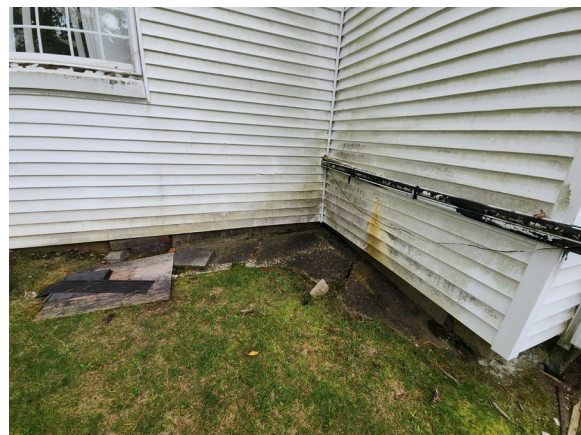
20. Northern Façade:

There is minor damage to the left corner roof eave. The windowsill on the corner towards the back that first one of three, the frame is in very poor condition. There is some rot and a lot of damage to the siding on this facade there should be investigation to determine moisture damage underneath a lot of this vinyl siding. The foundation is lower to the ground on this side so I'm not seeing much cracking and siding in the corner appears to have some moisture issues pretty much at connections of the buildings from runoff, gutters & downspouts at these locations would be ideal.

- a. Repair minor damage to the left corner roof eave.
- b. Repair window sill and frame, for window at back corner.
- c. Deteriorated areas of vinyl siding should be investigated to determine potential moisture damage underneath.

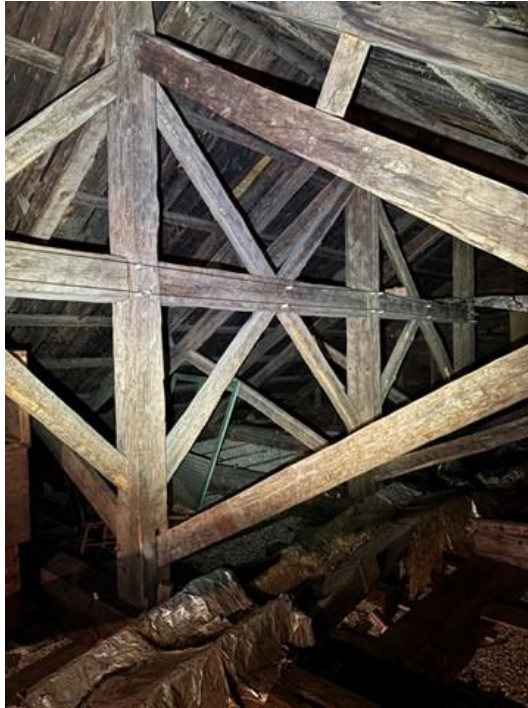
Photo 15: Missing brace in Main Truss

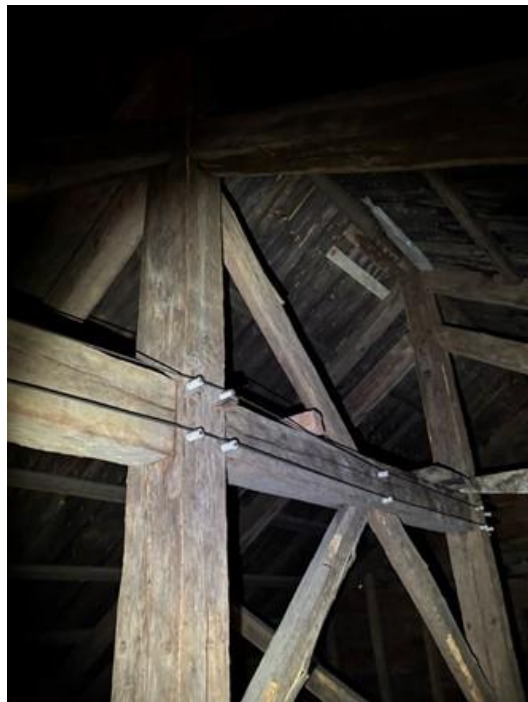
Photo 16: Missing brace in Main Truss
