**Town of Londonderry CIP Committee**  
**268B Mammoth Road – Moose Hill Council**  
**Chambers**  
**AGENDA**  
**August 11, 2025**  
**6:30 PM**

- I. Call To Order
- II. Approval Of Minutes From Prior Meeting

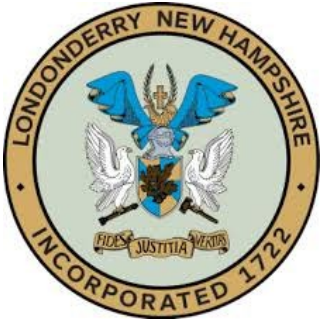
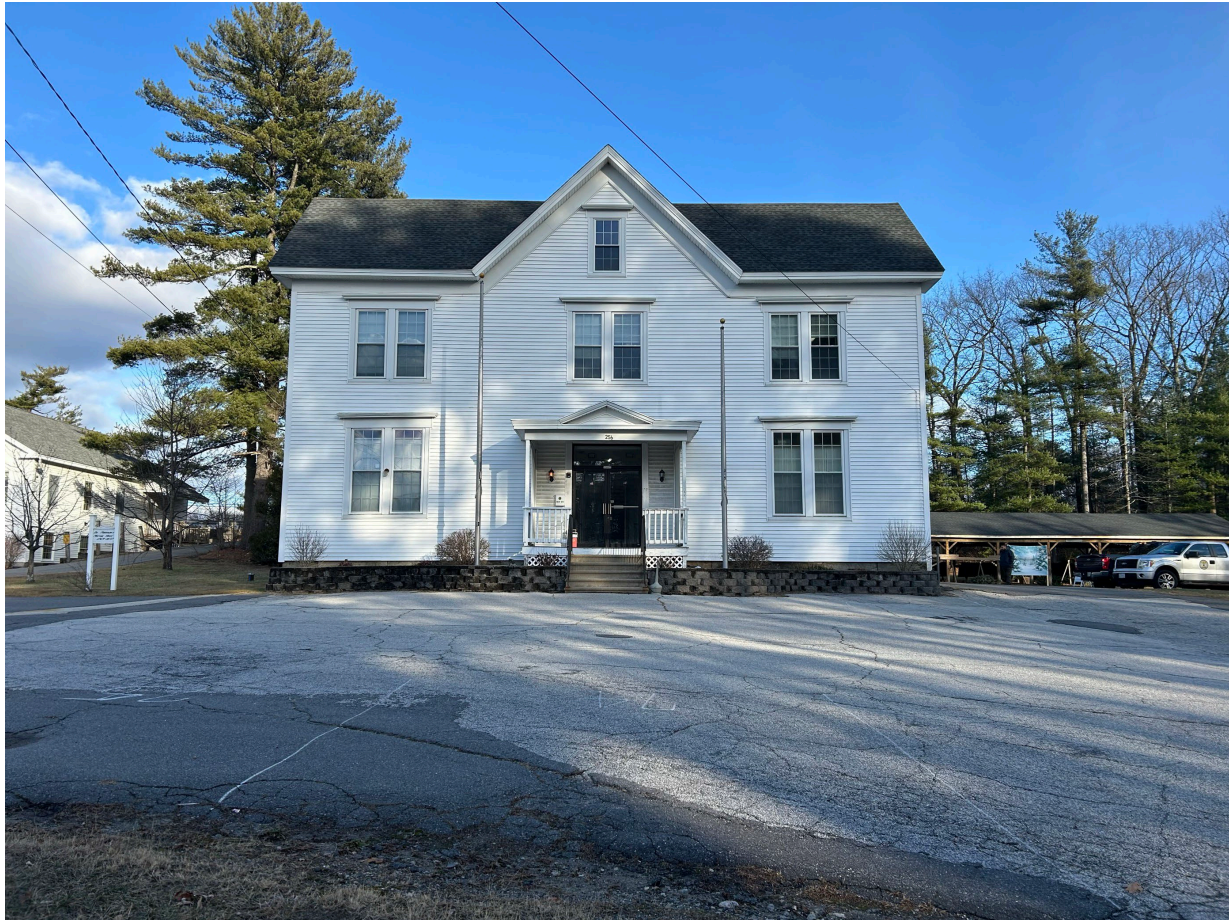
## Historic Building Conditions Assessment

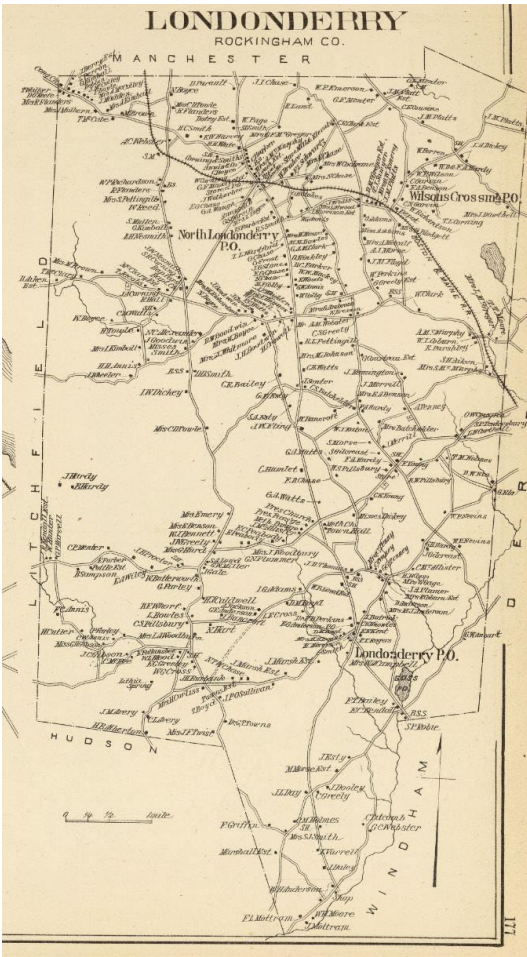
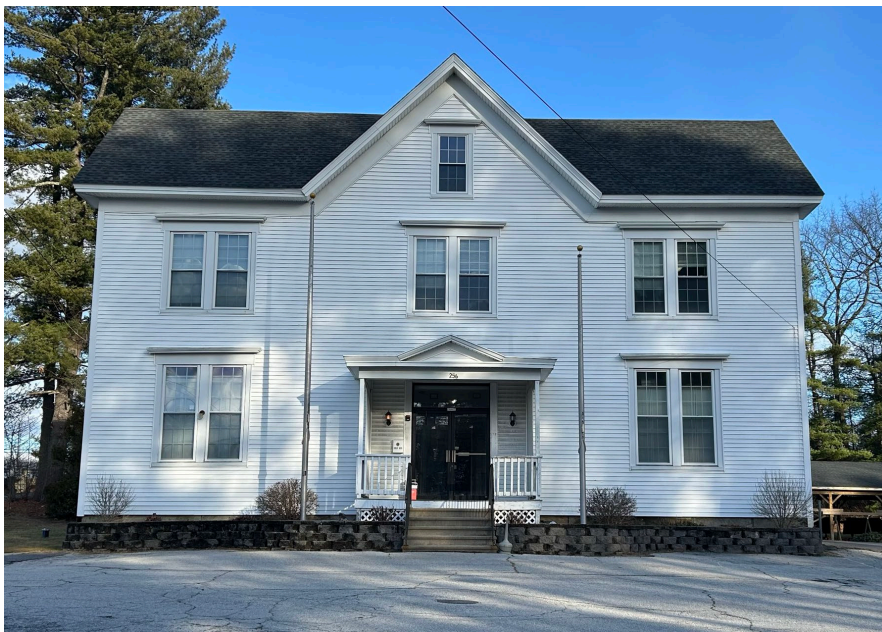
## Character Defining Features

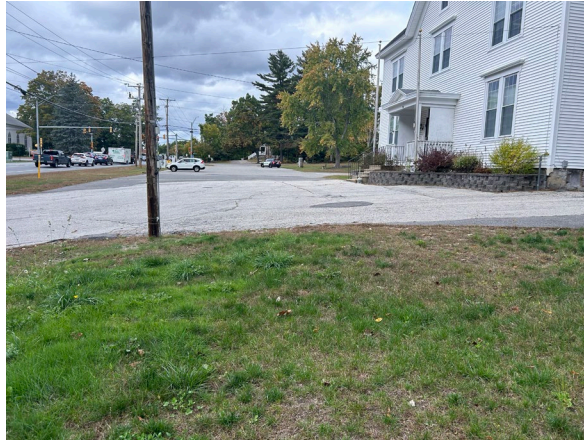
#### ***Important***

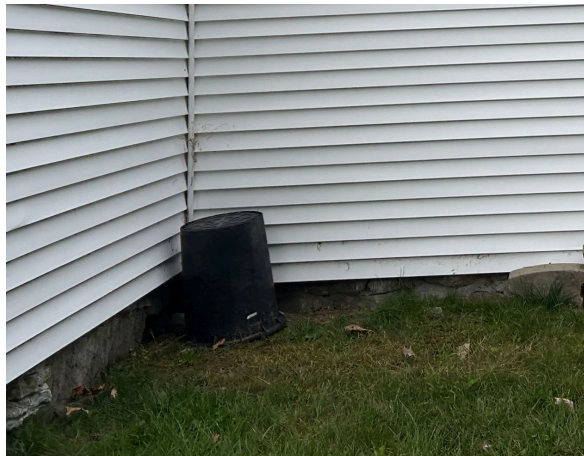
## 2. Exterior Character Defining Features

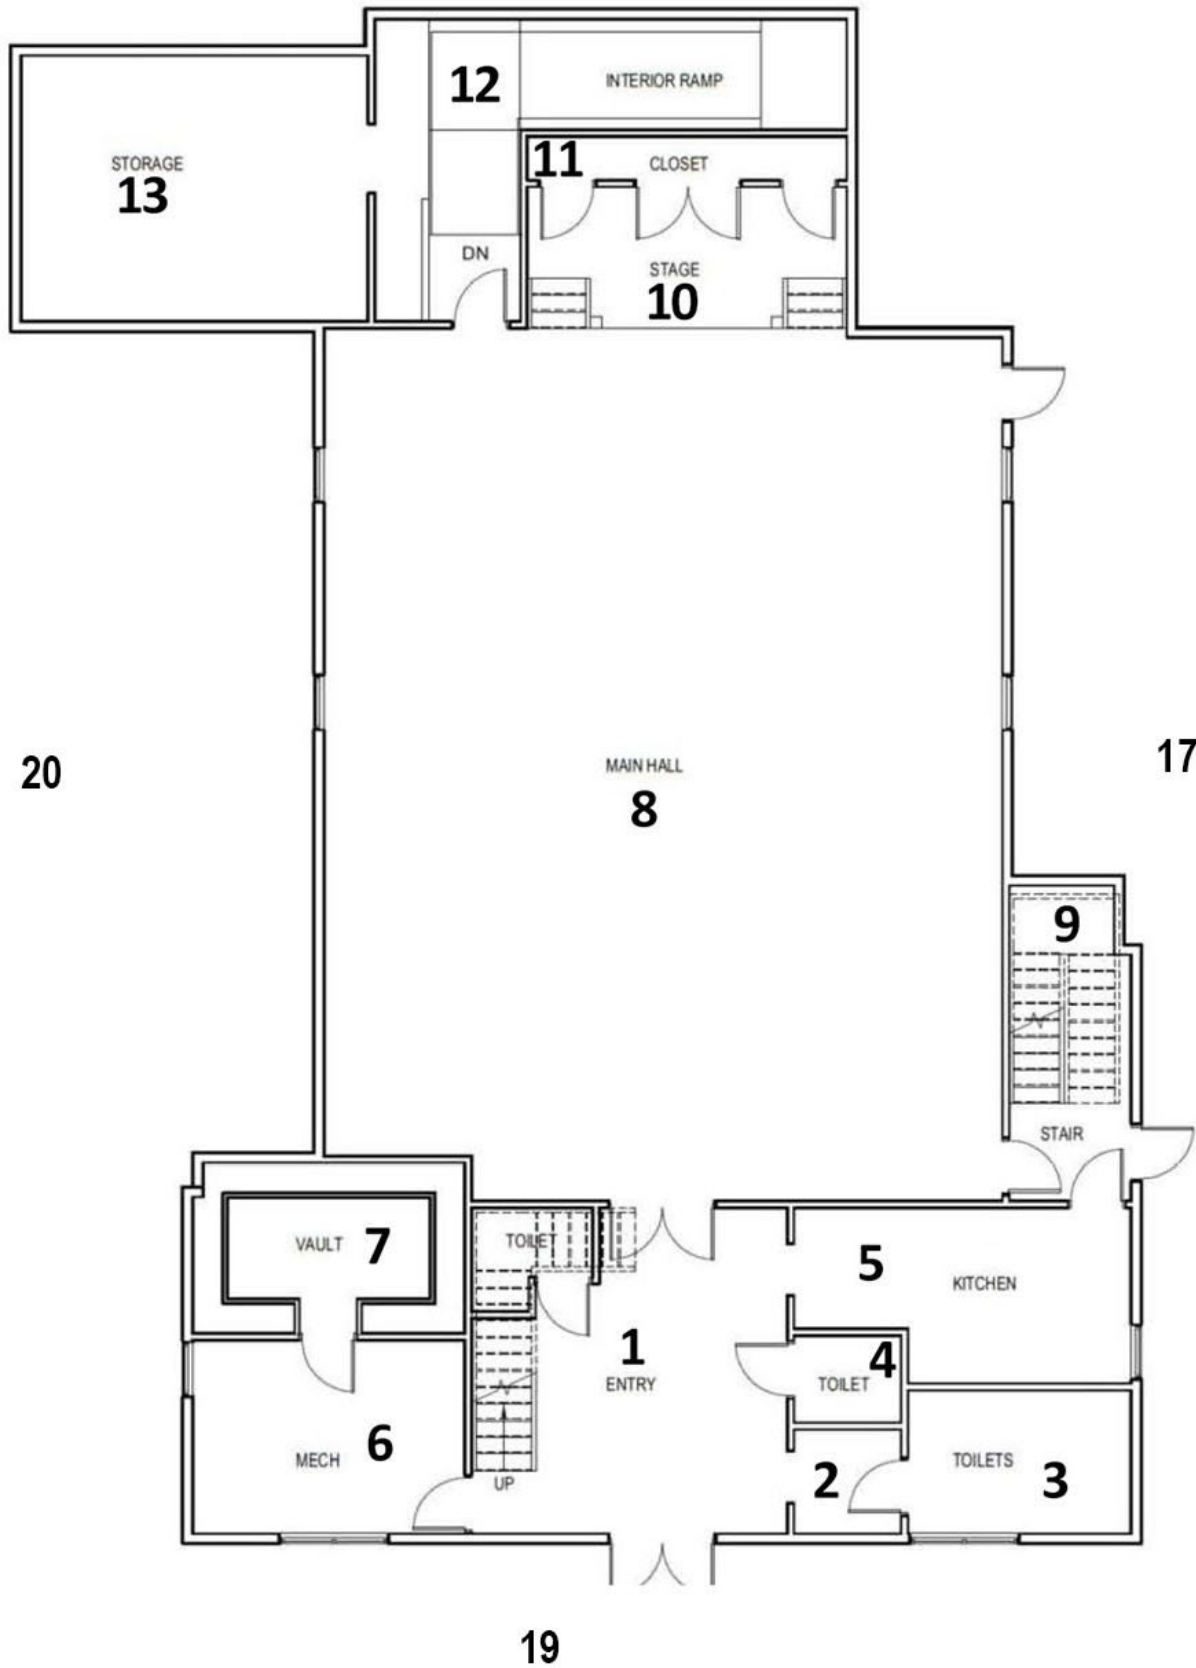
Figure 1: Floor Plans from Weston Sampson Report 2022

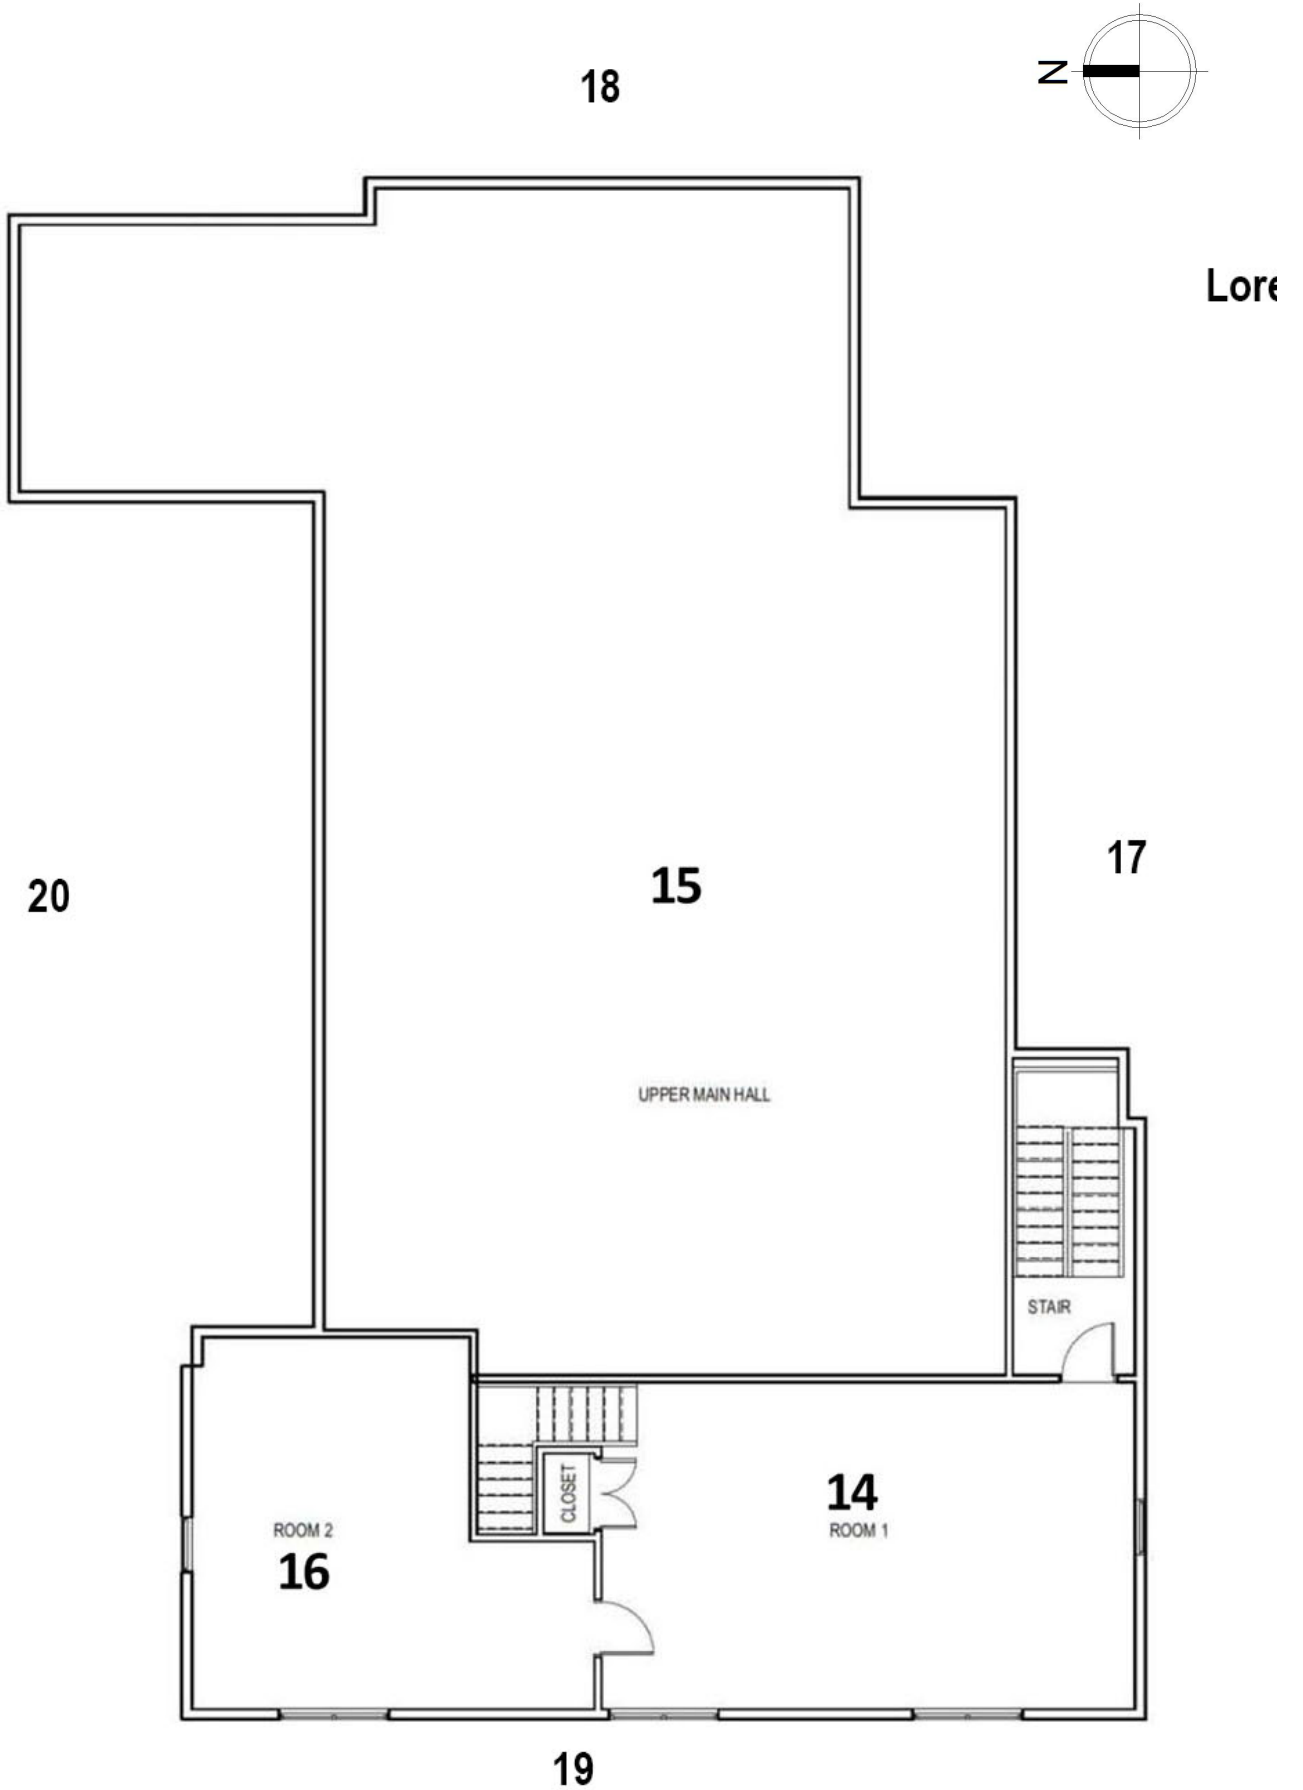
Figure 2: Floor Plans from Weston Sampson Report 2022

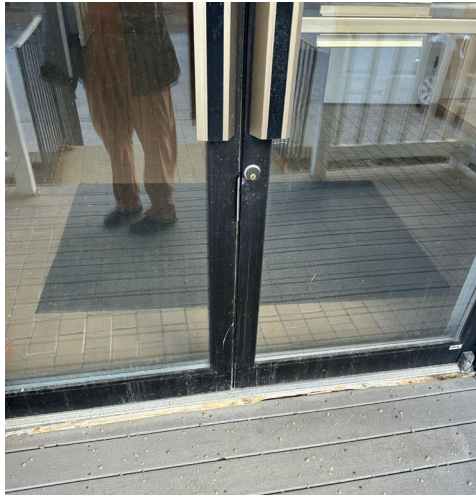
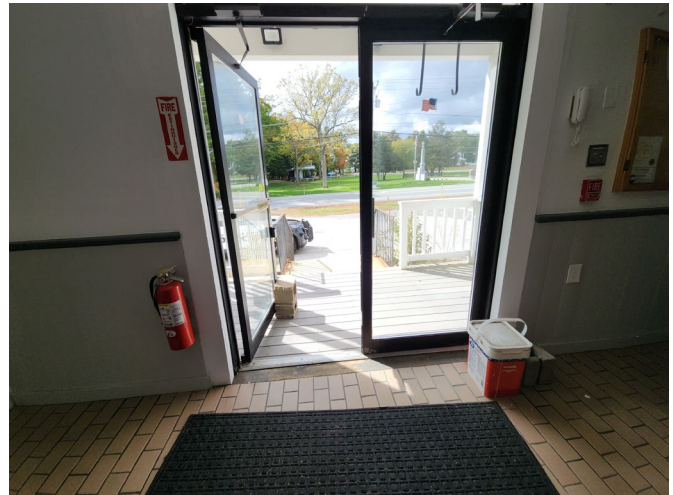
1: All entry finishes have been replaced in recent decades. Flooring has been replaced with modern tile and is not historic. The front doors are aluminum storefront replacement doors with no emergency exit hardware, and they're not properly weather sealed. The front entry threshold is level with the deck addition, which is modern, but the deck addition is not handicapped accessible because of the steps down to grade.

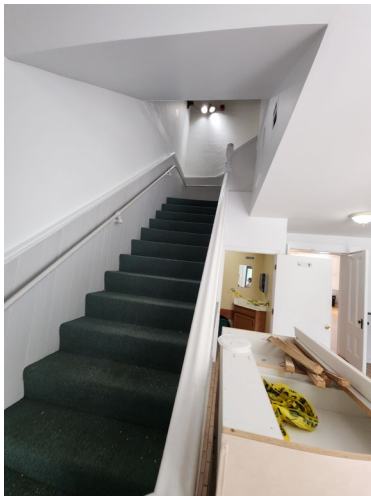
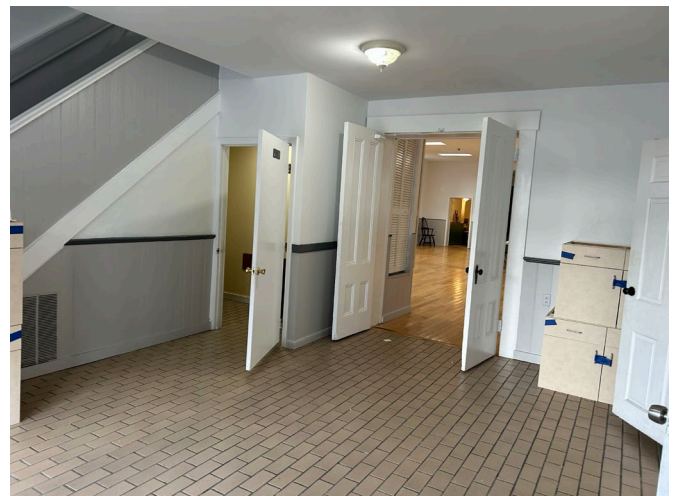
The ceiling is contemporary drywall with c. 1980s light fixtures, and smoke detectors. Similarly the walls are drywall with 1x6 flat stock door casings. The wainscot is painted bead board with chair rail, which might be original but the definition of the profile and beading is obscured by thick paint layered on over the years. The electrical outlets and switches are a mix of old and new. There is a fire alarm pull, telephone, and some emergency lighting on a shelf plugged into an outlet on the ceiling. There is forced air ventilation via ceiling and upper wall grills as well as a vent under the stair that is slightly damp and damaged.

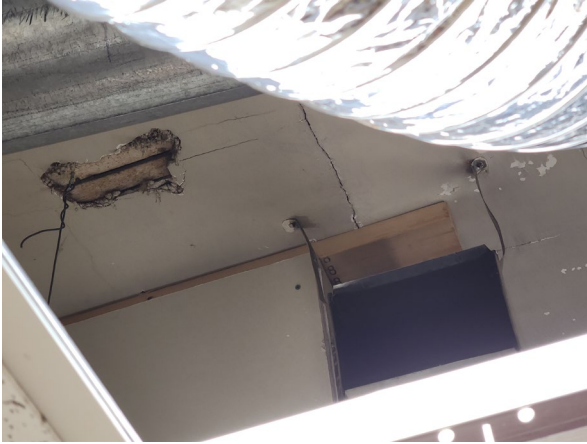
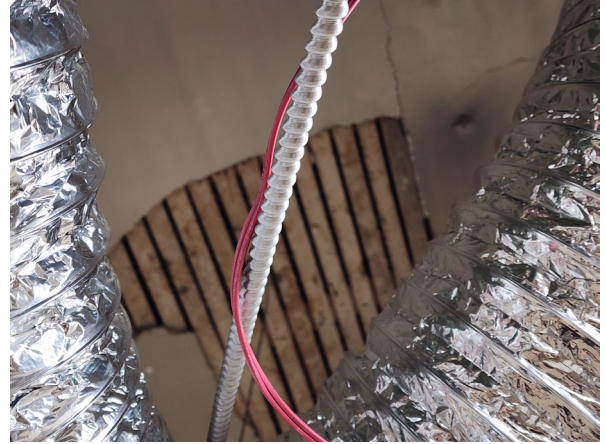
5: The kitchen is VCT 12x12 flooring, possibly c. 1980s plastic laminate. The countertops are chipped, warped, and crooked. The ceiling tiles are not in poor condition however, there is approx. 4-5' above the ACT ceiling, up to the original ceiling, which is lath on plaster. Some of the plaster is missing, and the lath on plaster that remains is terribly cracked. ACT ceiling has 2x4 lights. There is a small hot water tank underneath the microwave next to the window that is roughly 10 gallons.

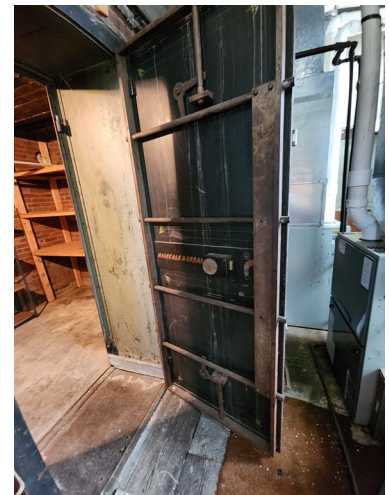
**7:** The Vault is a MacNeil with an urban steel door. It's secured into a very thick, 2' thick wall of brick and or concrete covered in brick. The wall between the vault and the auditorium is a cavity wall with two layers of brick and a 4" gap in the middle, which is unusual for this type of construction. The ceiling is wood with plaster and possibly brick above as well for safe keeping of whatever used to be in here. There's a very small vent in one corner.

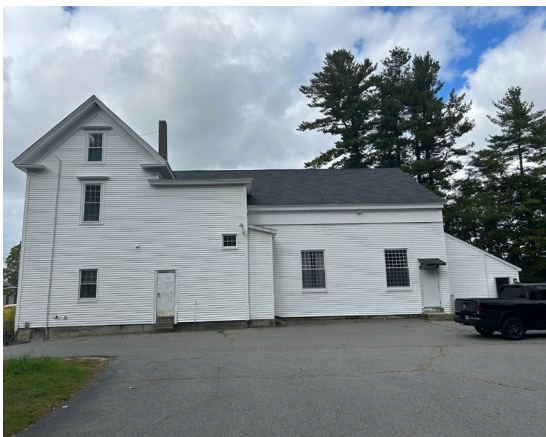
**17. Southern Façade:**

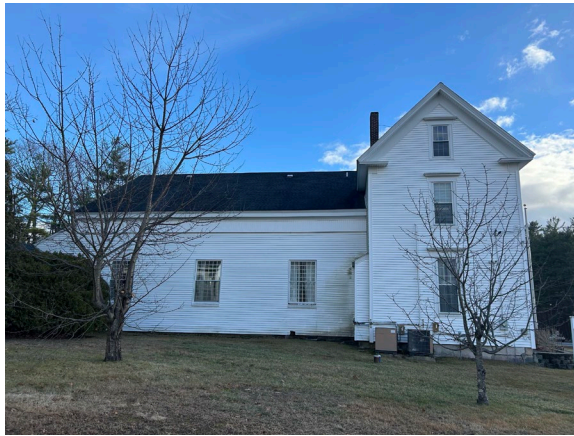
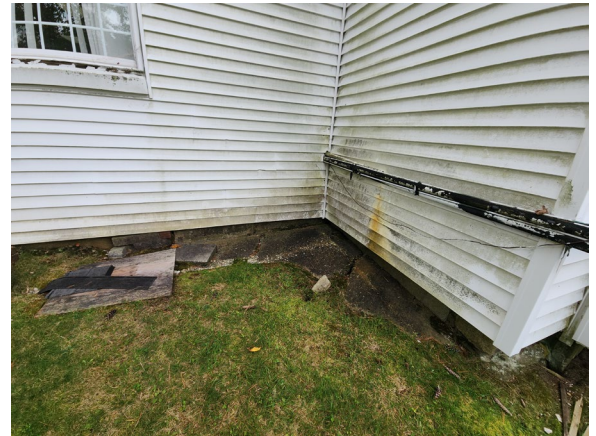
**20. Northern Façade:**

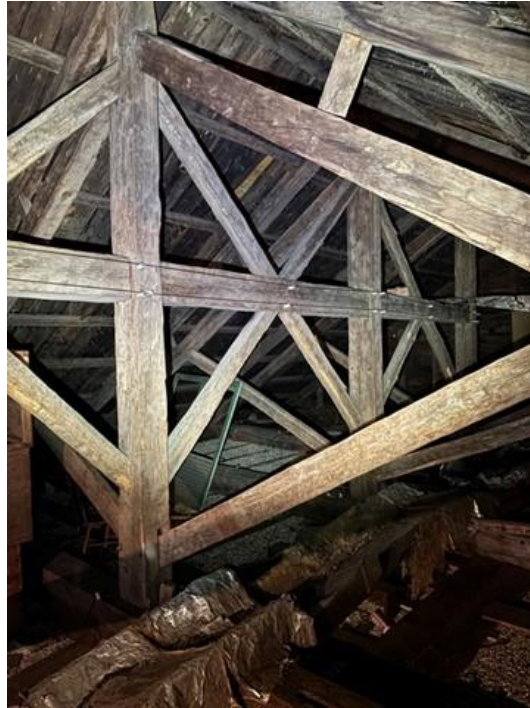
Photo 15: Missing brace in Main Truss

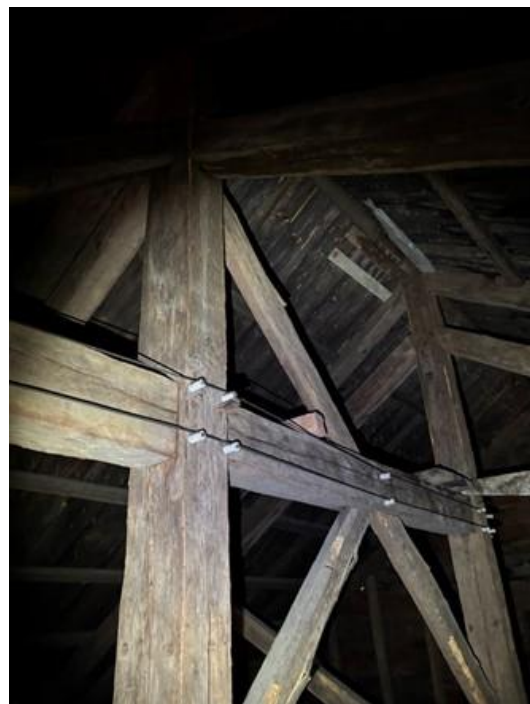
Photo 16: Missing brace in Main Truss

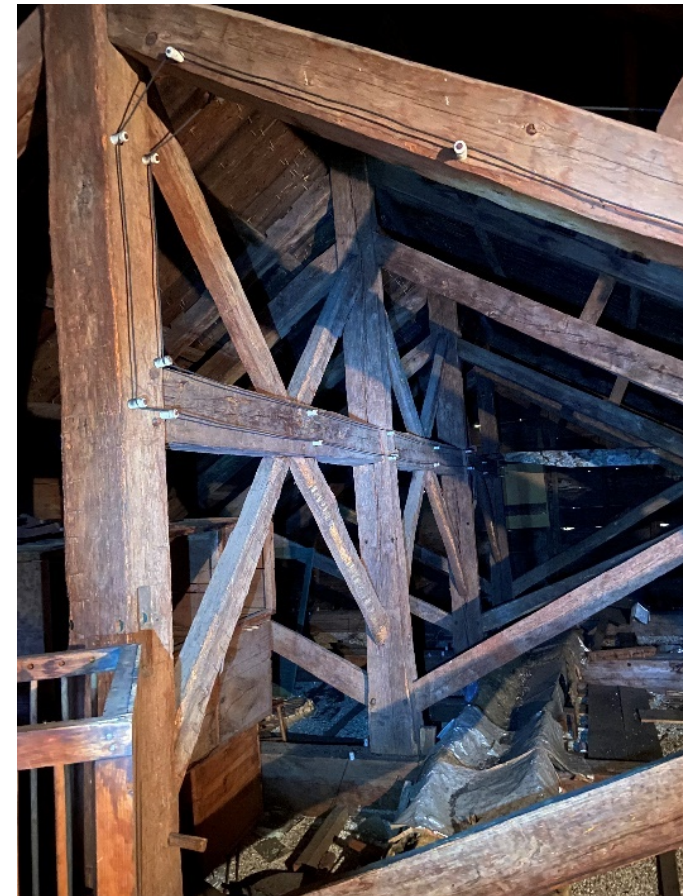
# What We Found - 2022

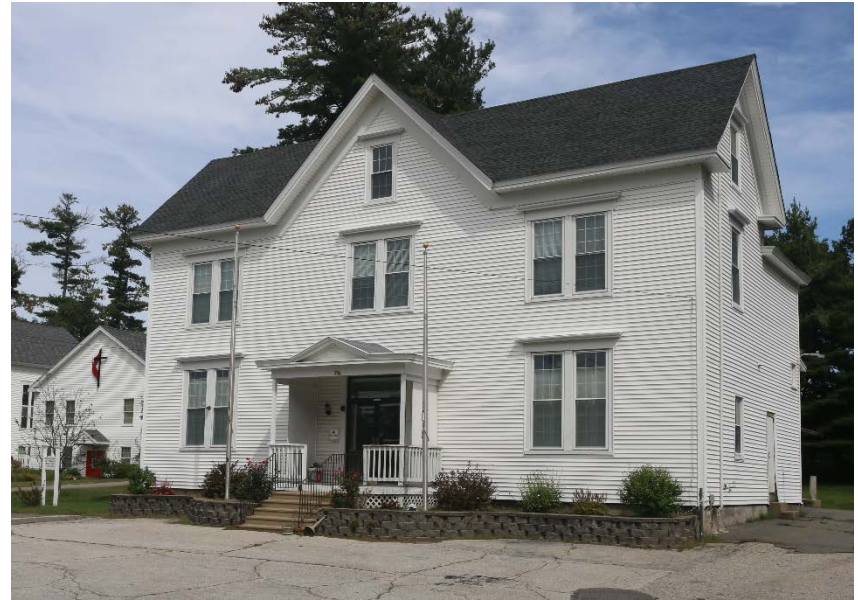
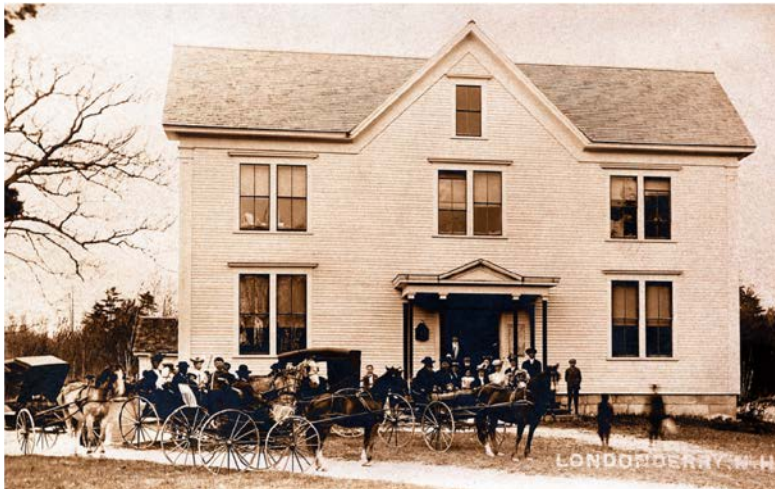
- Building Condition**
- Building Code Compliance**
- Accessibility**
- Energy Performance**
