Town of Londonderry CIP Committee
268B Mammoth Road - Moose Hill Council Chambers
AGENDA
August 11, 2025
6:30 PM

- I. Call To Order
- II. Approval Of Minutes From Prior Meeting

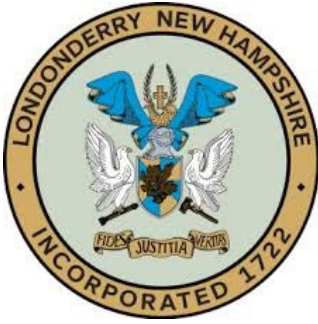
Historic Building Conditions Assessment

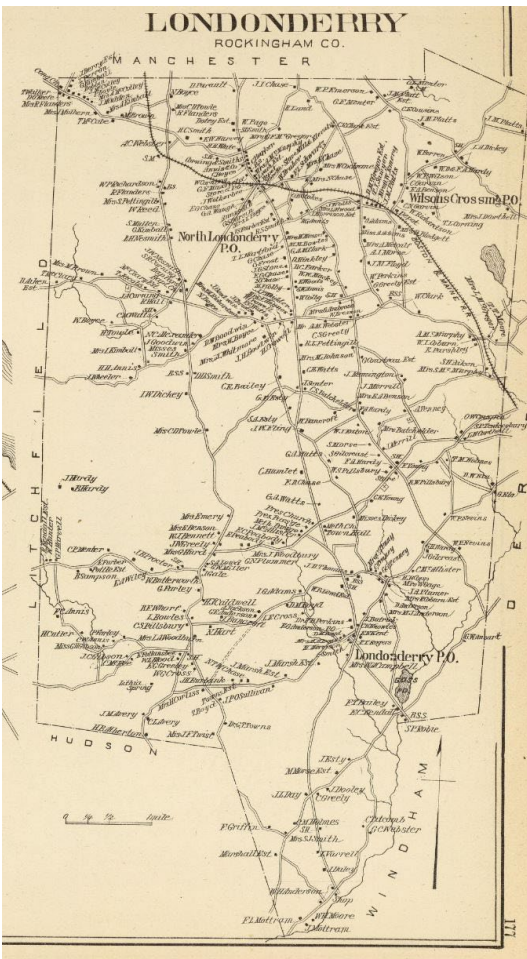
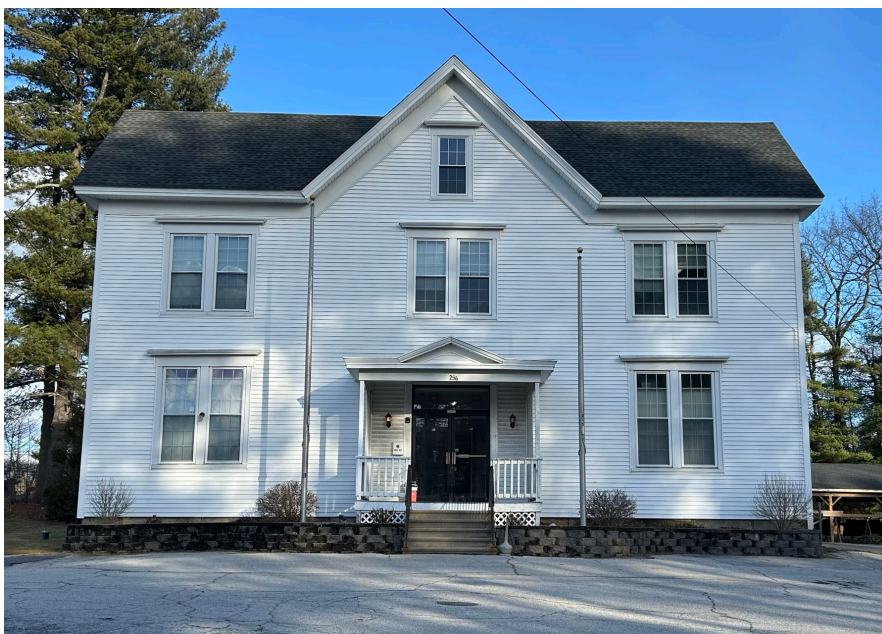
Character Defining Features

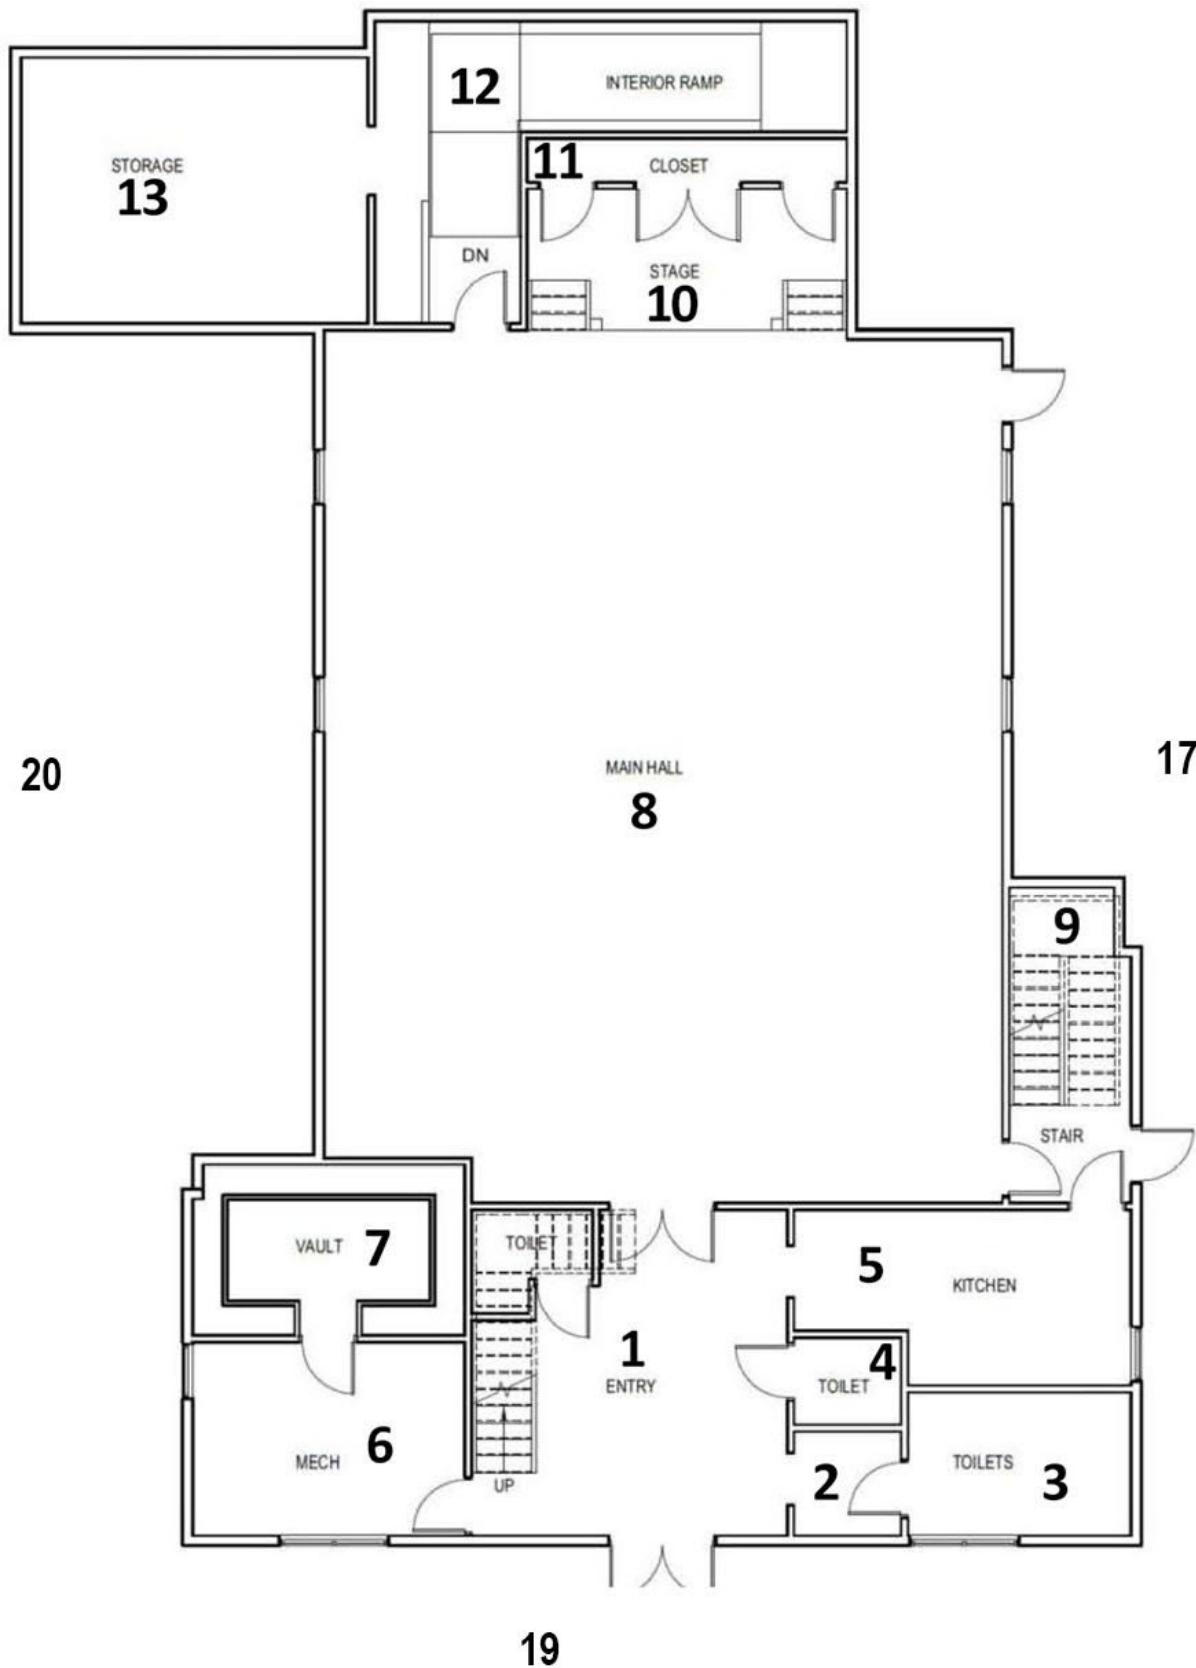
Figure 1: Floor Plans from Weston Sampson Report 2022

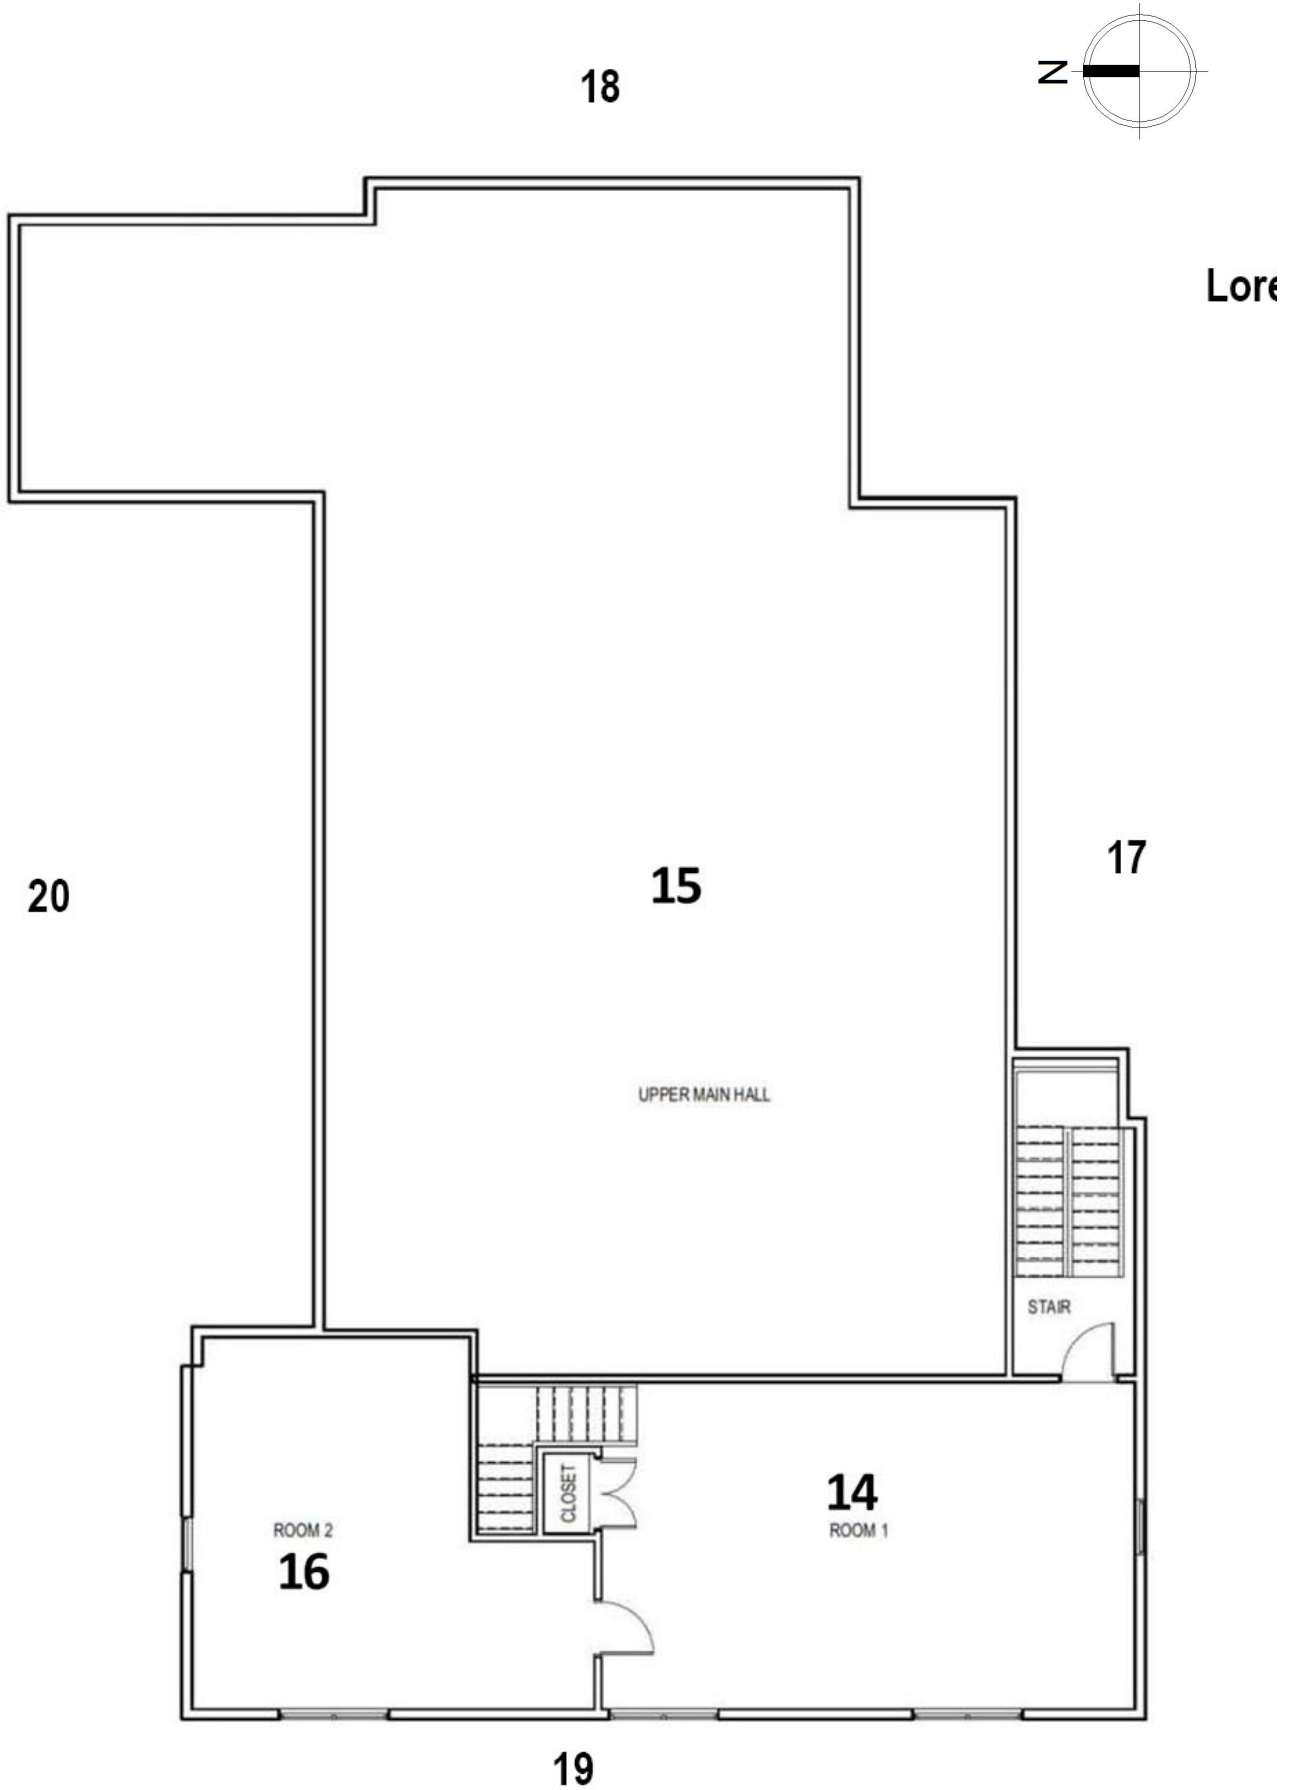
Figure 2: Floor Plans from Weston Sampson Report 2022

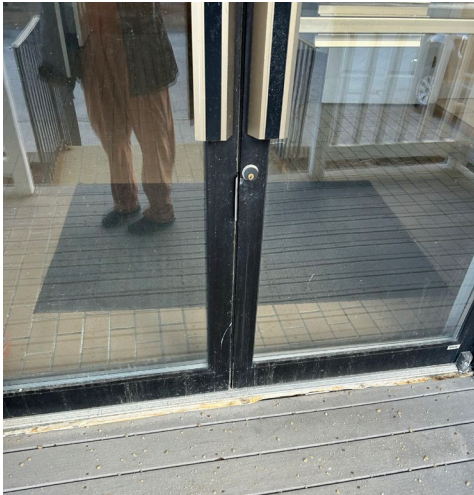
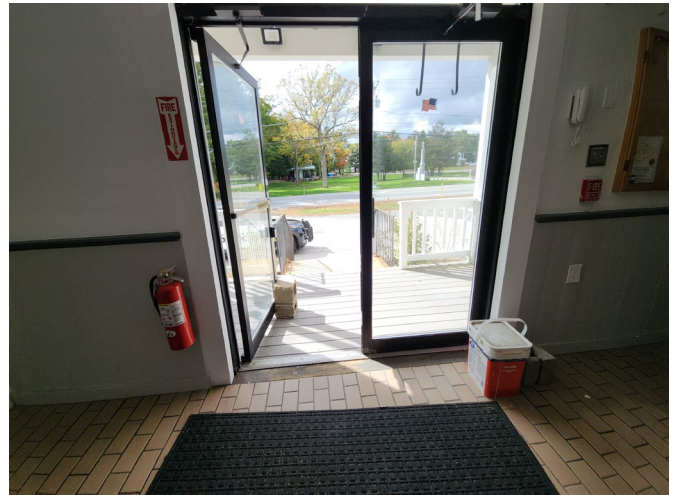
1: All entry finishes have been replaced in recent decades. Flooring has been replaced with modern tile and is not historic. The front doors are aluminum storefront replacement doors with no emergency exit hardware, and they're not properly weather sealed. The front entry threshold is level with the deck addition, which is modern, but the deck addition is not handicapped accessible because of the steps down to grade.

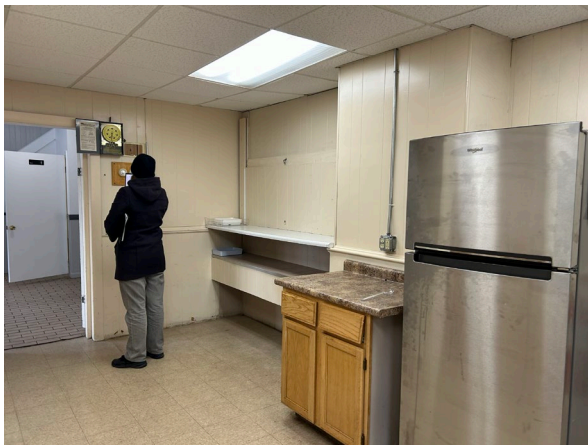
There is a refrigerator, fire extinguisher, surface mounted conduits, two quadruplex receptacle outlets, 70's era wood paneling, which has been painted on the walls. On the wall next to the door is a Dayton seven day dial, time switch, four pole, two normally open, two normally closed, and model number 2E21. The paneling seems original before paint.
