**Town of Londonderry CIP Committee**  
**268B Mammoth Road - Moose Hill Council Chambers**  
**AGENDA**  
**August 11, 2025**  
**6:30 PM**

## Historic Building Conditions Assessment

Reverend William Morrison Meeting House  
Londonderry, NH

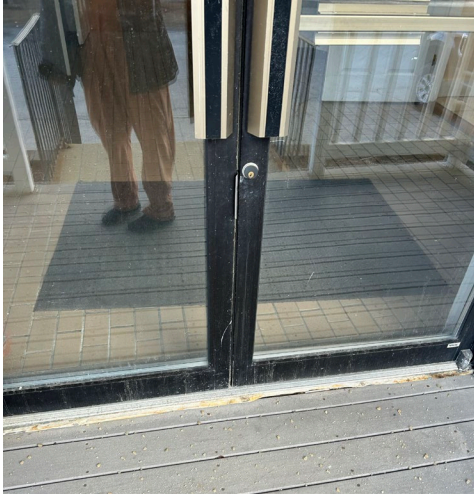
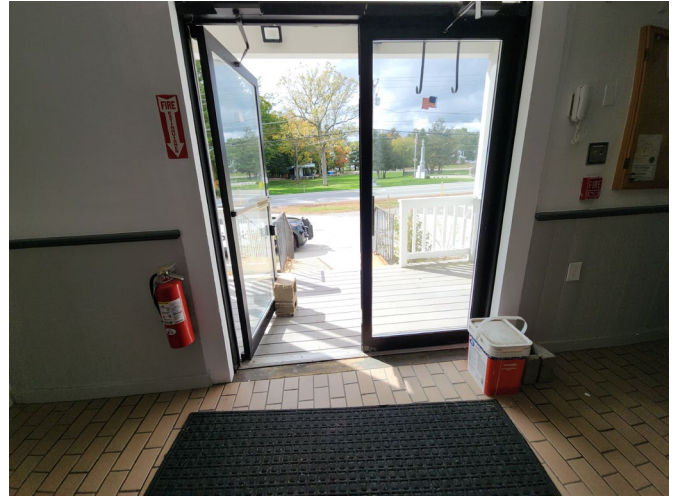
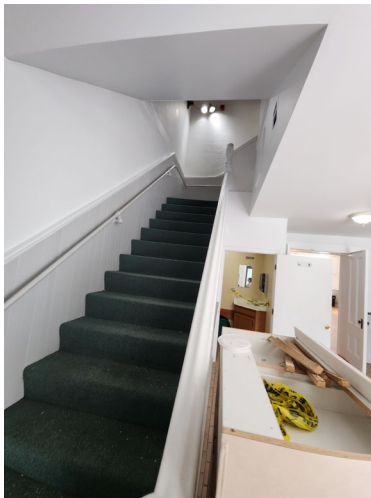
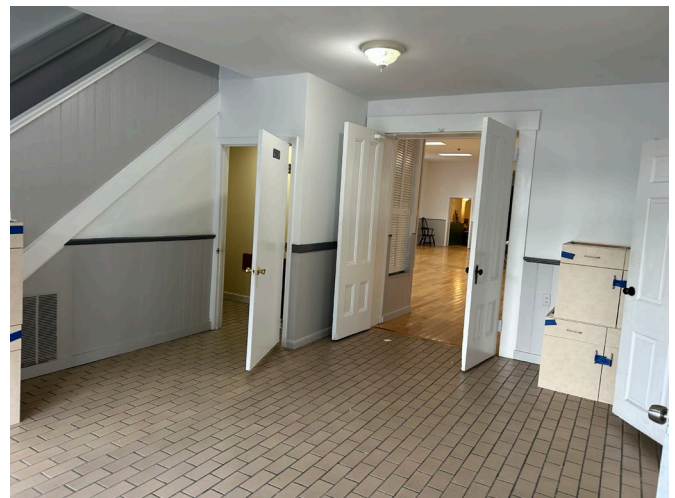
1: All entry finishes have been replaced in recent decades. Flooring has been replaced with modern tile and is not historic. The front doors are aluminum storefront replacement doors with no emergency exit hardware, and they're not properly weather sealed. The front entry threshold is level with the deck addition, which is modern, but the deck addition is not handicapped accessible because of the steps down to grade.

The ceiling is contemporary drywall with c. 1980s light fixtures, and smoke detectors. Similarly the walls are drywall with 1x6 flat stock door casings. The wainscot is painted bead board with chair rail, which might be original but the definition of the profile and beading is obscured by thick paint layered on over the years. The electrical outlets and switches are a mix of old and new. There is a fire alarm pull, telephone, and some emergency lighting on a shelf plugged into an outlet on the ceiling. There is forced air ventilation via ceiling and upper wall grills as well as a vent under the stair that is slightly damp and damaged.

- a. Aluminum storefront entry doors: These contemporary doors are functional and may remain, although replacement with period appropriate doors is recommended. Minimum work needed includes:

- c. For fire separation between open stair and auditorium, repair any cracks or gaps in ceiling and wall drywall or plaster in the stairway and entry foyer. Doors between auditorium and foyer require functioning closers and panic hardware, and smoke seals; repair damaged and missing bottom corners of historic door panels.

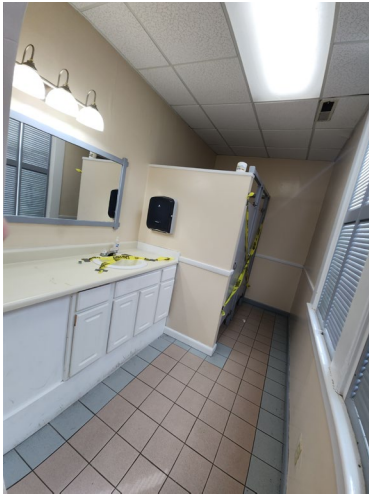
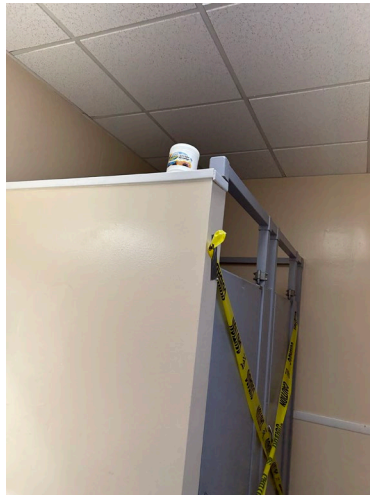
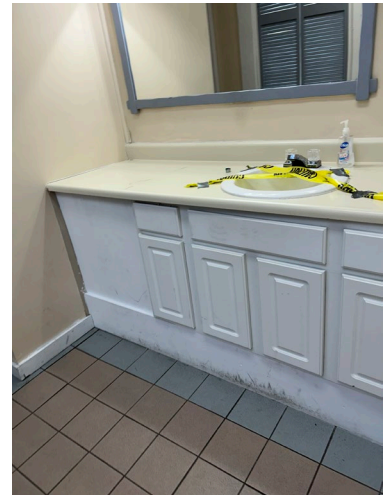
**3:** In the Women's bathroom, there are shutters on the windows, the walls are modern drywall, bathrooms are not handicap accessible. There is one sink and a solid counter below. The counter height is 37". There are two toilet stalls, not handicapped accessible, and all the plumbing is taped off with caution tape for winter. The millwork under the sink counter, is all circa 1980s and it's contoured plastic laminate countertop with the MDF prefab door panels, which are mounted crooked. In poor condition, there is a CT ceiling emergency lighting, ceiling vents, and large 2x4 fluorescent light fixture, the painted wood shutters on the windows don't open as they are screwed shut.

- a. New layout, fixtures, and door hardware/thresholds are required for handicap accessibility. Expansion into the kitchen area may be required. The kitchen could be relocated to the Storage space north of stage (#13 on plan) if that area was to be insulated and weatherproofed. The remaining remnants of historic wood wainscot should be repaired and preserved where possible.

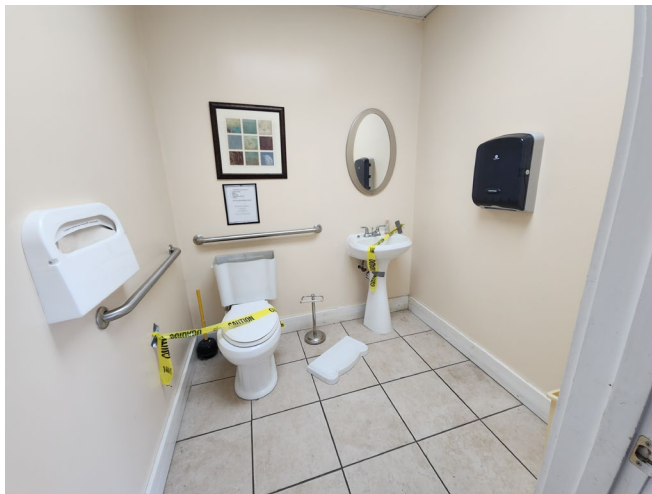
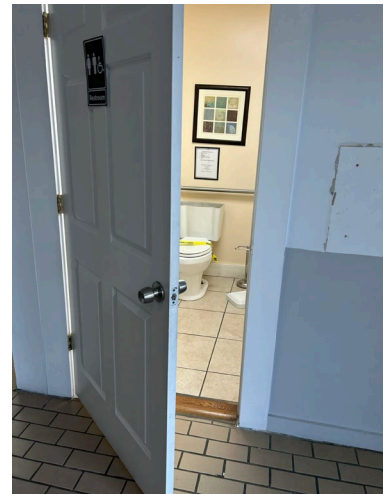
**4:** The handicapped bathroom is spacious though a little worn out, there is a possibly c. 1980s pedestal sink with lever faucet, and the toilet has appropriate grab bars however is missing the vertical bar. The door hardware is not handicapped accessible and is a 6 panel style replacement door. The door threshold is also not handicapped accessible due to the trim at the floor transition.

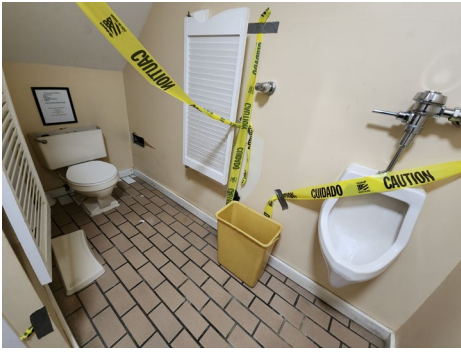
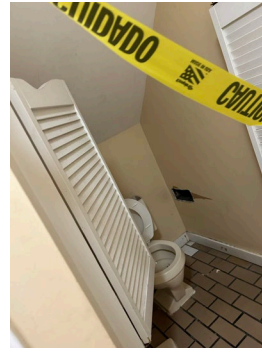
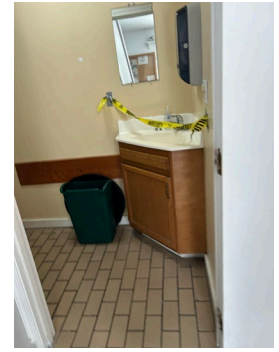
4.5: The men's bathroom under the stair is not ADA accessible, and has a saloon style stall.

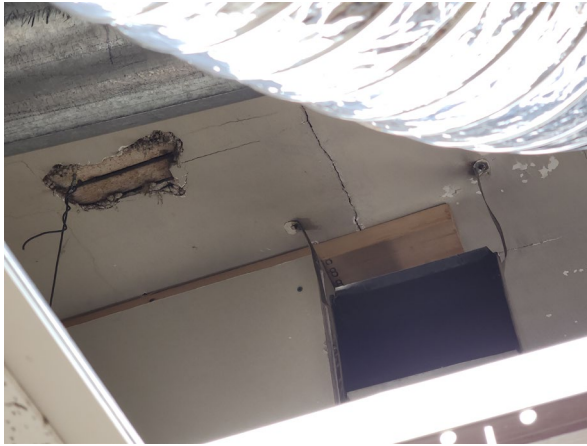
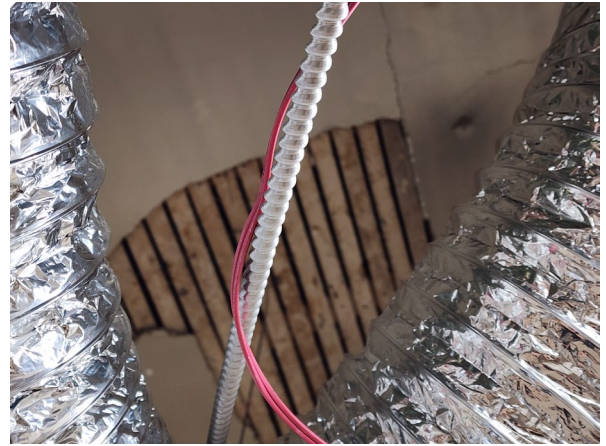
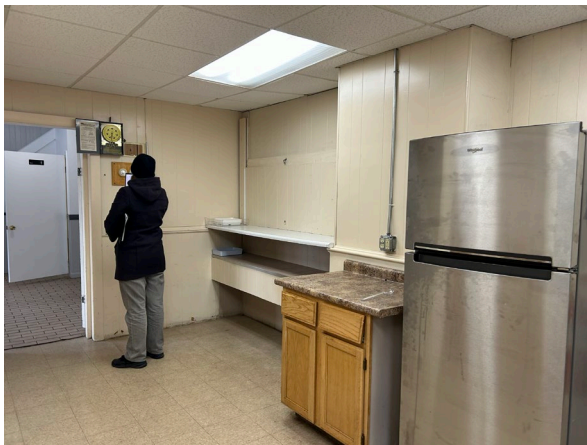
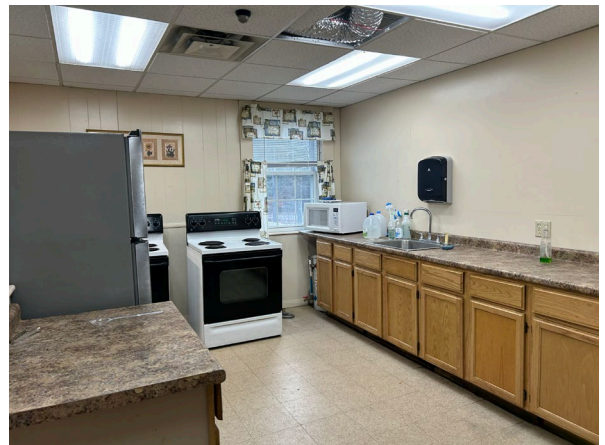
5: The kitchen is VCT 12x12 flooring, possibly c. 1980s plastic laminate. The countertops are chipped, warped, and crooked. The ceiling tiles are not in poor condition however, there is approx. 4-5' above the ACT ceiling, up to the original ceiling, which is lath on plaster. Some of the plaster is missing, and the lath on plaster that remains is terribly cracked. ACT ceiling has 2x4 lights. There is a small hot water tank underneath the microwave next to the window that is roughly 10 gallons.

There is a refrigerator, fire extinguisher, surface mounted conduits, two quadruplex receptacle outlets, 70's era wood paneling, which has been painted on the walls. On the wall next to the door is a Dayton seven day dial, time switch, four pole, two normally open, two normally closed, and model number 2E21. The paneling seems original before paint.

5: Kitchen: Finishes are worn throughout, some in poor condition – especially the ceiling. See #3 above for Kitchen relocation suggestion.

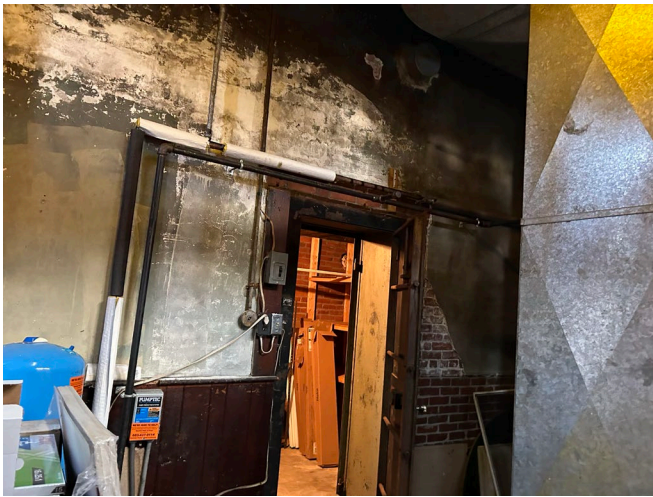
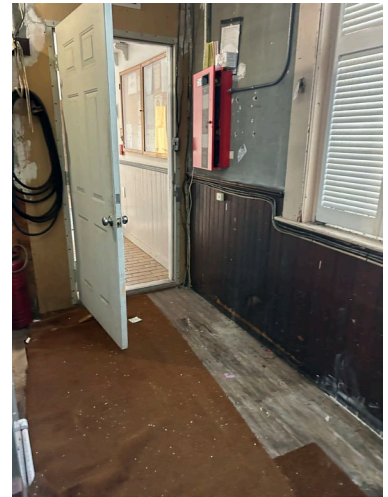
**6:** The boiler room has period beaded wood paneling below the chair rail and plaster on lath above, which are in worn condition. There are modern, bi-fold, wood interior shutters. The windows are Harvey vinyl, double hung, double glazed with grills between the glass, with no screen or storm windows, installed in 2005. There is a vault behind the furnace powered by gas. Behind the furnace is a pressurized expansion tank installed in 2006 that feeds the furnace.

6: Boiler room - See item #24 below for HVAC system. Wall finishes are worn but historic and would benefit from some repair and repainting.

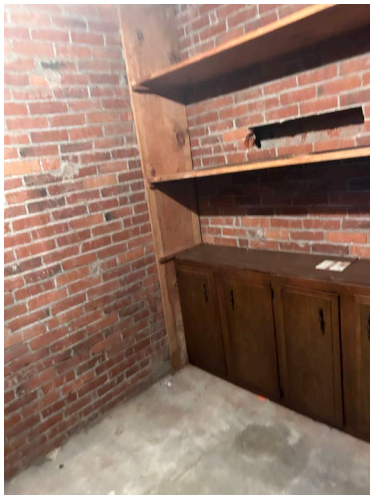
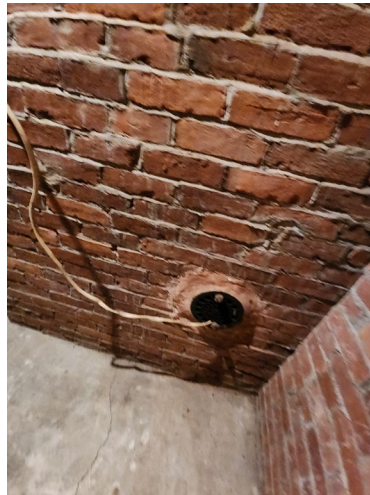
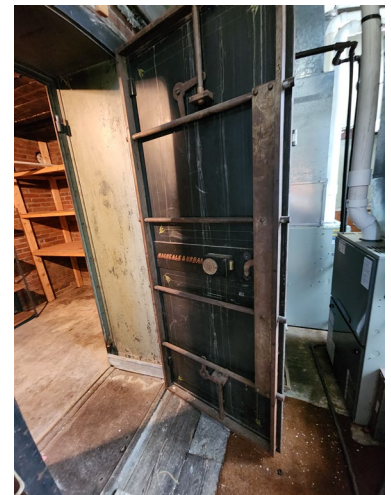
**7:** The Vault is a MacNeil with an urban steel door. It's secured into a very thick, 2' thick wall of brick and or concrete covered in brick. The wall between the vault and the auditorium is a cavity wall with two layers of brick and a 4" gap in the middle, which is unusual for this type of construction. The ceiling is wood with plaster and possibly brick above as well for safe keeping of whatever used to be in here. There's a very small vent in one corner.

7: Vault: This space is historic, no work other than general cleaning and maintenance is recommended.

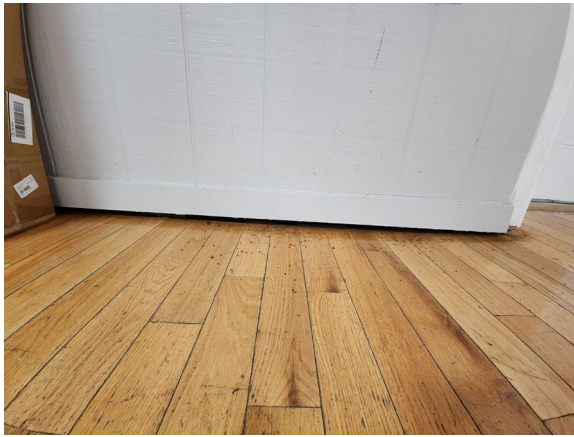
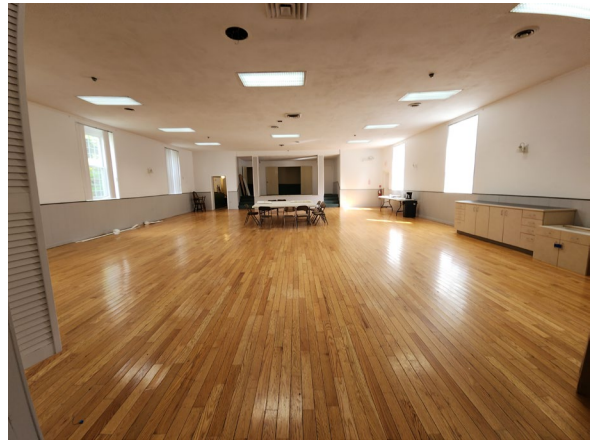
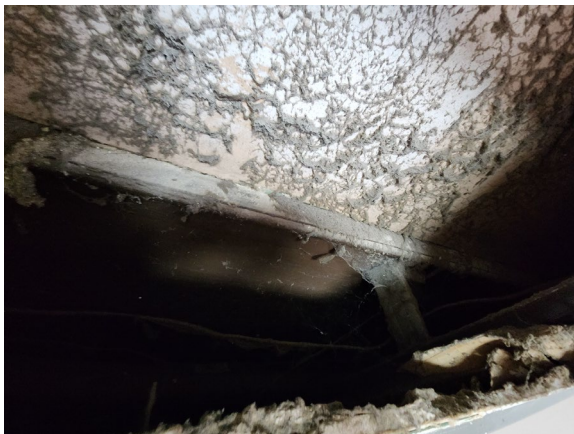
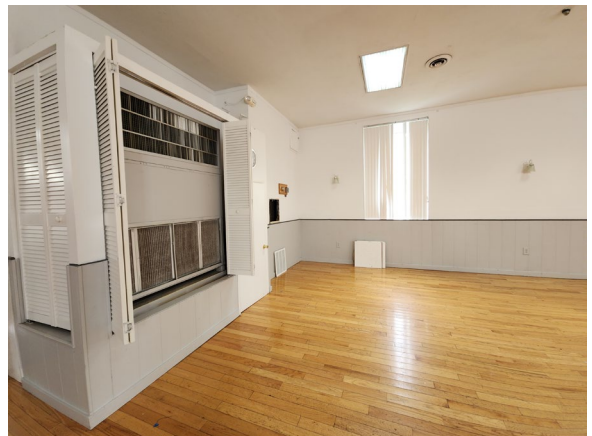
**8:** Auditorium the main entry doors into the entry hall do appear to be original, four panel doors that are not equipped with handicapped hardware. There is a very tiny residential grade closer on each leaf with what used to be a closing rod in the middle which has been removed. The bottom corners are eroded and chipped away. The perimeter walls are modern painted drywall, set in from the original exterior walls and the windows are double hung, Harvey vinyl replacement windows. The ceiling is a dropped drywall soffit and the original tin ceiling and structure is hidden above, in poor condition but could be restored.

The cavity behind the modern walls near the vault shows the original walls had wood horizontal boards below a chair rail with plaster. We cannot see the original walls along the side, exterior walls without selective demolition, which will occur at a later time. The base board hovers above the floor by a couple of inches. The settlement is one inch at the rear wall. There are rodent droppings everywhere, especially at the back wall of the auditorium, kitchen, and in the vault. They probably live in the cavities of all the walls around the building. We do have some grounded outlets here and light switching, two thermostats and a timer. Transaction window to the kitchen, the oak hardwood floor looks like it has been recently refinished and is not level.

- a. Remove the contemporary interior perimeter furring walls. Repair or replace in kind the revealed historic wood wainscot and plaster walls.
- b. Remove the contemporary dropped ceiling and soffits, to reveal the original tin ceiling above. Repair in kind where required. Strip any flaking paint and repaint.
- c. The oak hardwood flooring appears recently refinished however may need refinishing, repair or replacement upon process of repairing and releveling the floor framing (reference attached structural report).

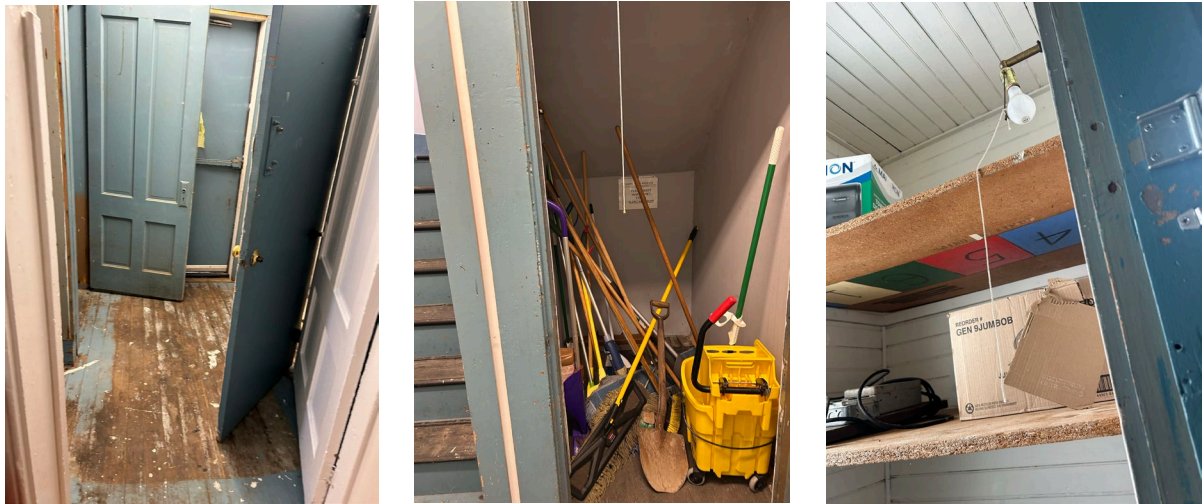
**9:** The front stair hall has very worn paint, painted flat wood trim, and drywall in very poor condition. There is broom storage underneath the stair and rubber treads at the mid landing, as well as another small closet with some shelves and a painted beadboard interior. There is only one handrail at each side of the stairwell landing. The door at the bottom of the stair goes outside to the south parking lot and has a narrow, 30", c. 1950's panic bar. The frame is worn, rotted, poorly insulated, and in overall poor condition. The door to the kitchen is an old hollow core door, in poor condition, with a broken door knob. The door into the main auditorium does appear of an older vintage, with partially missing late 19th century door hardware and flat stock trim.

- a. Replace or repair the very worn finishes at walls, ceiling and treads.
- b. Install handrail on the side without a handrail.
- c. Replace the worn door at the bottom of the stair exiting to exterior with a wider (36") code compliant door and hardware.
- d. Replace door between fire stair and auditorium with a wider (36") 45 minute fire rated door and code compliant exit hardware.
- e. Closets and storage within a fire exit stair are prohibited and should be removed.

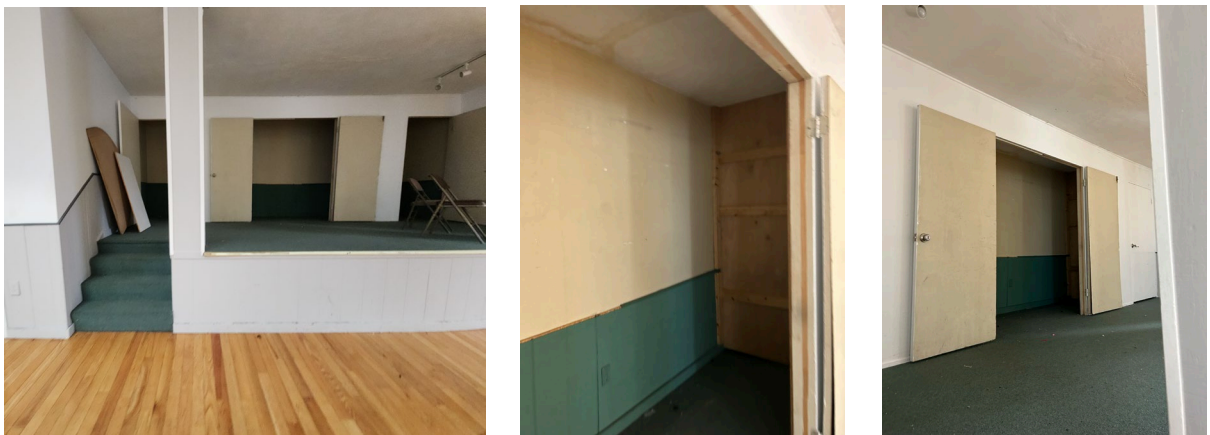
**10 & 11:** The exit door from the stage to the outside has very old panic hardware and closer, and is in need of refurbishment. There's an exit sign above, emergency lighting, fire alarm, station, fire extinguisher. There is a stage platform with steps on either side, which has c. 1980s paneling, textured plaster, ceiling on drywall. There is some circa 1980's track lighting, and worn green carpeting in poor condition. There is another 100 amp electrical panel, stage left, which is not labeled.

There does appear to be some water damage at the ceiling above the stage that worsens when inside of the closet behind the stage. The height of the stage platform is 32" above the auditorium and there are no proper handrails.

- a. The exit door from the stage to the exterior requires weatherstripping and new code compliant exit hardware.
- b. Stage finishes and lighting are not historically significant, they are functional but worn, and would benefit from updates.
- c. Repair ceiling and roof flashing at location of visible water damage above the stage and backstage
- d. Handrails should be installed at the side stage steps.

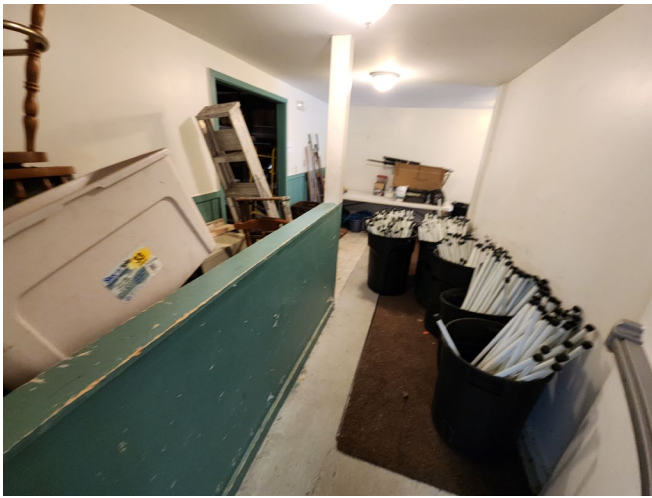
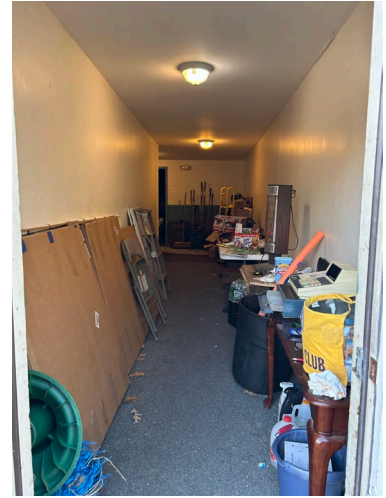
**12:** The storage behind the auditorium is the current ADA access to the building as the floor is ramped however there is storage obstructing the pathway. It ramps from the auditorium to the back hallway in an ell, until you reach the door to the parking lot.

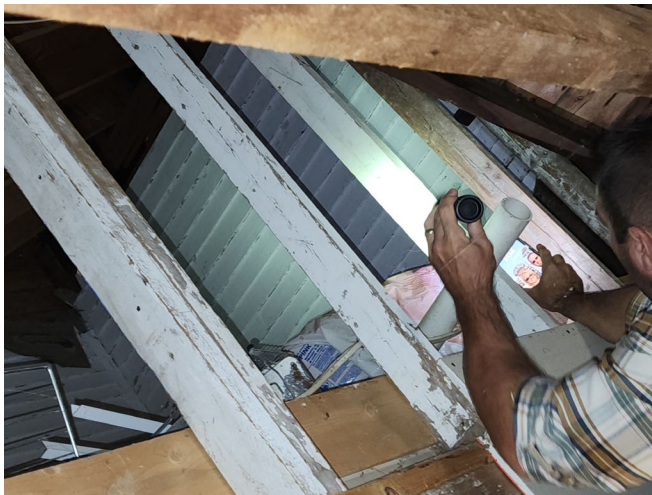
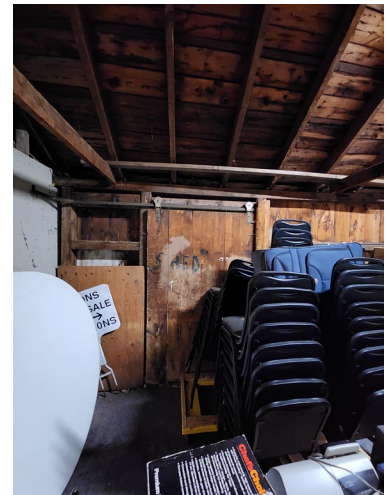
**13:** The storage shed addition is framed with 2x6 lumber. There's no ridge plate or ridge beam and appears to be approximately 100 years old or more, but not post and beam. The floor has carpet and is not level. There's a sliding track barn door on one side, the wall sheathing shows quite a bit of moisture intrusion, as does the roofing boards, which have been splintered and there are gaps, but it appears to have been covered with new roofing to keep the water out currently. The old siding is evident in the attic, above the connector, behind the stage in the shed.

- a. The tops of walls and roof framing show some sagging, reference attached *Structural Assessment report*.
- b. Wall and roof sheathing shows signs of past moisture damage. Inspect and repair roofing and flashing in this area.
- c. If this area is to be occupied for programmed space (such as a relocated kitchen), insulation, interior finishes, doors, and MEP will be required.

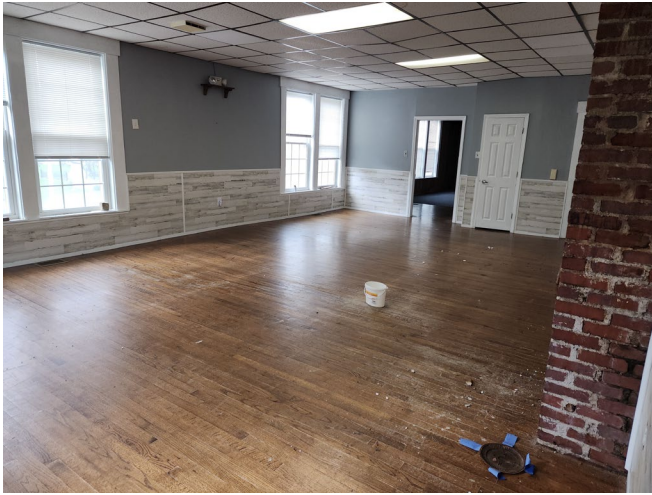
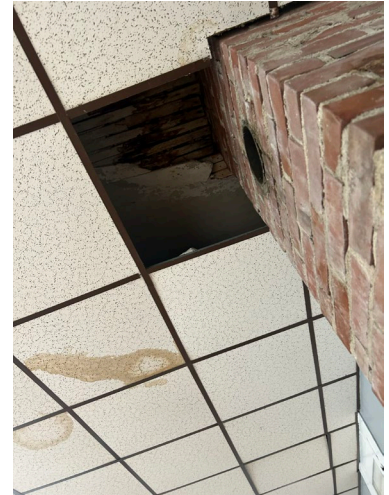
**14:** The upstairs meeting room has narrow hard oak flooring. The floor is not level and is warped. There's a high point in the middle, and then it dips down to either side. There's modern wallpaper, drywall, and trim that has been redone over the years. There's a hatch in the upper wall providing access to the attic. The ceiling is 2x2 ACT and has evidence of moisture damage especially in the area around the chimney. Above the ACT is the original ceilings in relatively poor condition.

- a. Reference structural report for sagging floor areas above first floor windows.
- b. Inspect and repair roofing and flashing at chimney above areas of ceiling moisture damage.

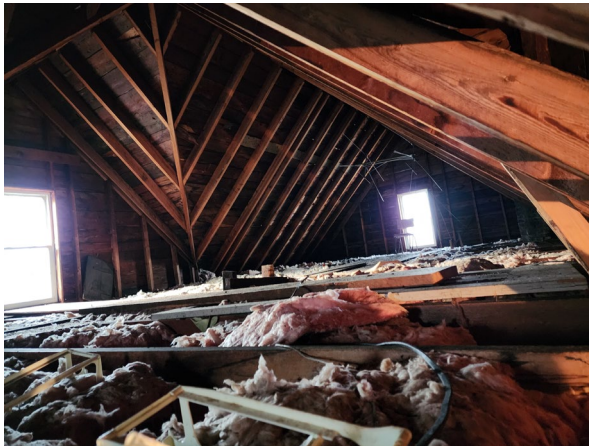
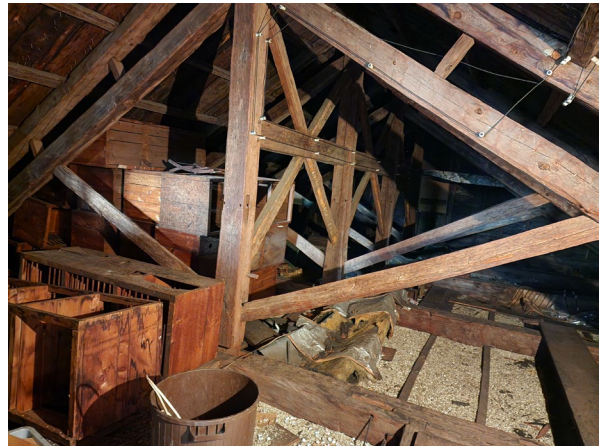
**15:** The attic above the main hall has blown in insulation at the attic floor, and cellulose. There is old knob and tube wiring throughout, and no sprinkler system. RE: Structural report

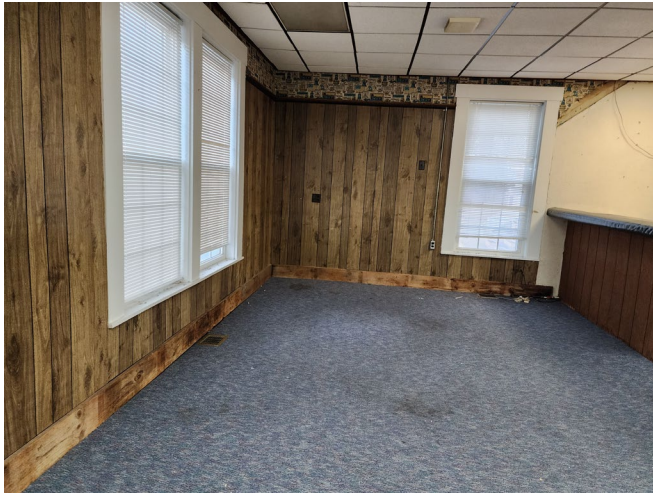
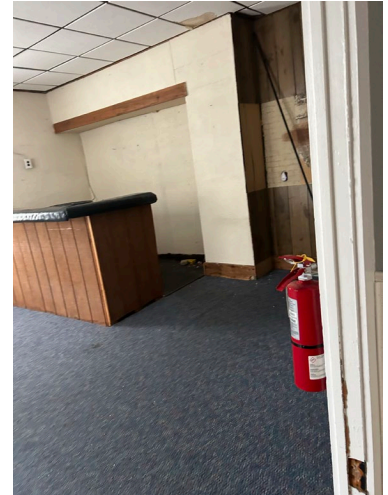
**16:** The side upstairs meeting room appears to be the Lions Club bar with c. 1970s and 1980s wood paneling, carpeting, ACT ceiling. There is nothing original to the building and it all appears in poor condition. In the attic there was access further up to the attic over the front entry space however there were no floorboards, though it was insulated. Not accessible due to dangerous conditions.

16: North side upstairs meeting room: Repair or replace worn, non-historic finishes.

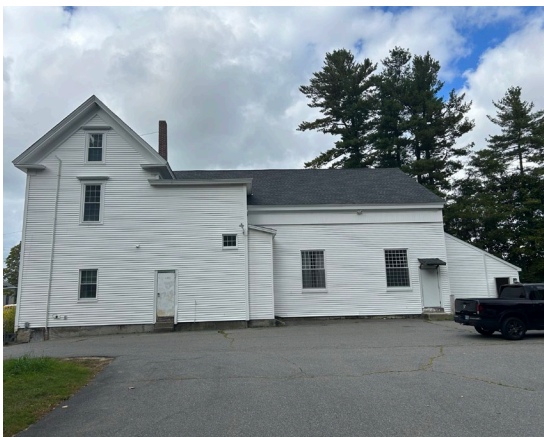
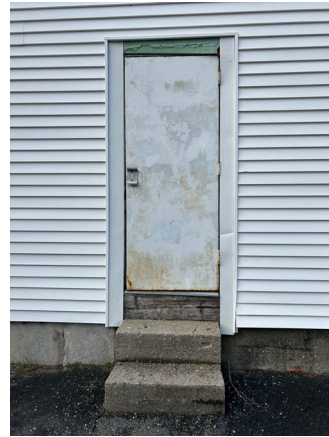
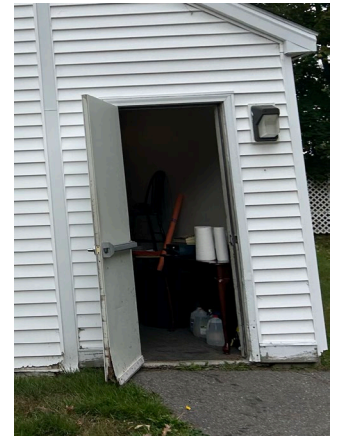
**17. Southern Façade:**

There is an access panel to the crawlspace of the basement and a pipe that goes all the way down. The metal side door to the stairwell is rusted, not plumb, and there is evidence of rot within the door frame. There is cracking in the foundation throughout the façade. There are no downspouts or gutters however, there is a large overhang from the fascia and soffit with a drip edge. The windows are Harvey replacement windows. There is minimal damage to some of the siding, with the original siding hidden underneath that appears to be pretty cracked. The back side door to the stage is also metal and the wood trim is slightly worn but in better condition than the other door. There is some minor damage to the bottom, left corner with some of the wood exposed, the paint is chipped, but the wood itself is in decent condition other than a small portion that has rotted. There are major holes and gaps in the foundation of the back addition's foundation and [art of the siding is in poor condition towards the bottom of that foundation. The back side door that provides ADA access to the building is metal and is in better condition than the other two, however the metal has split from the wood. The trim is slightly damaged at the bottom right.

- a. Reference structural report for foundations.
- b. The back side door frame and trim needs repair.

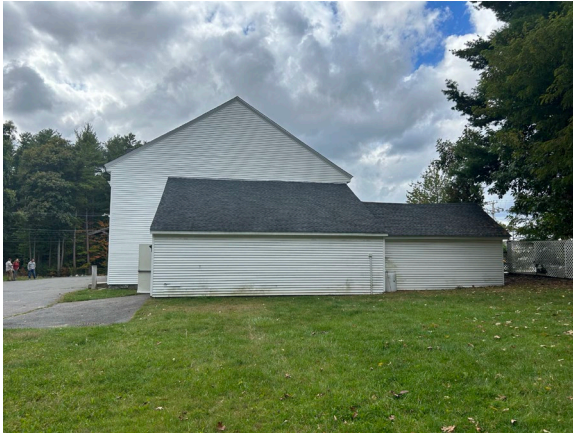
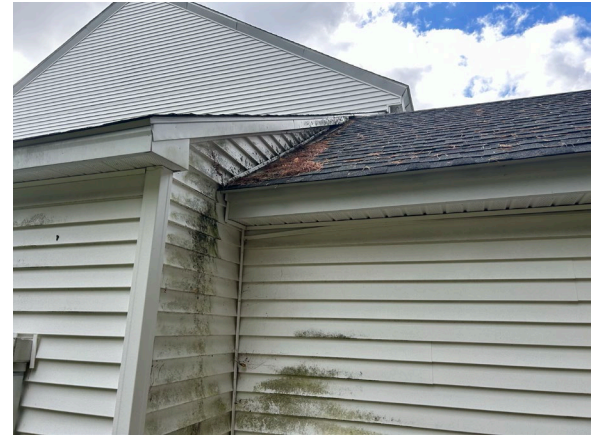
### 18. Eastern Façade:

The eastern façade has siding in very poor condition. The foundation is less exposed and in areas where it is exposed it looks in decent condition. The back corner of the building connection to the shed has some severe runoff and warping that may need some selective demo in order to investigate if there is moisture damage underneath, and the underside of the roof is also worn. The siding to the shed additionally needs to be cleaned and has some minor cracks, the wood underneath appears not too bad.

- a. The back corner of the main building at connection to shed shows signs of moisture damage at wall and soffits from roof water runoff. Localized removal of siding and trim is recommended to determine extent of damage and repair needed in this area.
- b. The siding at shed addition needs to be cleaned, minor cracks should be repaired.

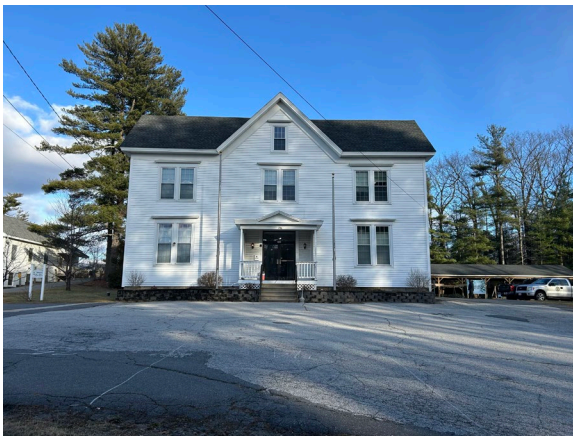
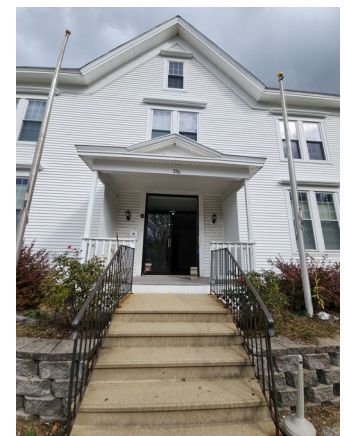
### 19. Western Façade:

The front porch's paint is chipped, the underside of the roof eaves look in good condition, though there is some minor damage on the front roof eave but not too severe. Some of the siding is cracked and the foundation's mortar looks like it's in need of some repair. The wood appears to be mostly sound, there is minor damage and it's in need of cleaning. Some of the siding at the front door siding is also chipped and peeling. The wood itself at the bottom of the door frame is very worn, and there is some cracking to the wood, but not too severe. There is some cracking at the wood on the left side of the porch floor support, the front left column. The mortar on the front left side also needs to be repaired. The windows are in good condition. 39" height to front entry

- a. Portico needs repainting.
- b. Repair minor damage on front roof eave
- c. Repair minor cracks in siding and wood trim, clean and repaint as required.
- d. The wood at the bottom of the door frame needs repair.
- e. Repair cracked wood on front left portico post.
- f. Reference *Structural Assessment Report* for foundations.

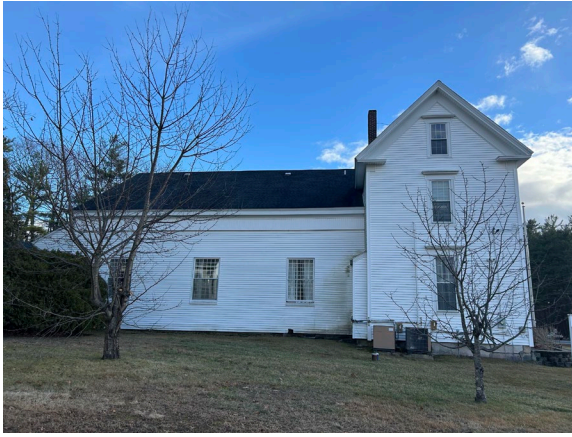
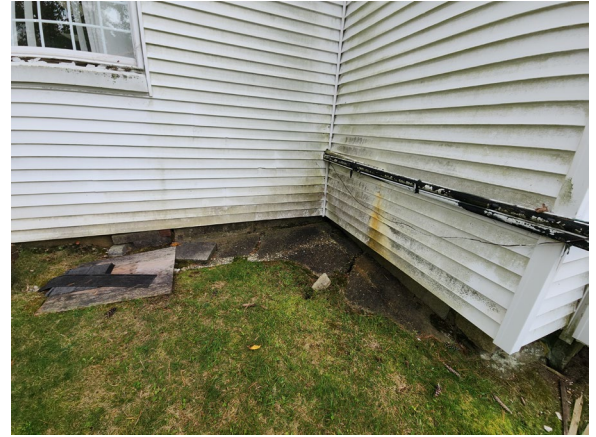
**20. Northern Façade:**

There is minor damage to the left corner roof eave. The windowsill on the corner towards the back that first one of three, the frame is in very poor condition. There is some rot and a lot of damage to the siding on this facade there should be investigation to determine moisture damage underneath a lot of this vinyl siding. The foundation is lower to the ground on this side so I'm not seeing much cracking and siding in the corner appears to have some moisture issues pretty much at connections of the buildings from runoff, gutters & downspouts at these locations would be ideal.

- a. Repair minor damage to the left corner roof eave.
- b. Repair window sill and frame, for window at back corner.
- c. Deteriorated areas of vinyl siding should be investigated to determine potential moisture damage underneath.

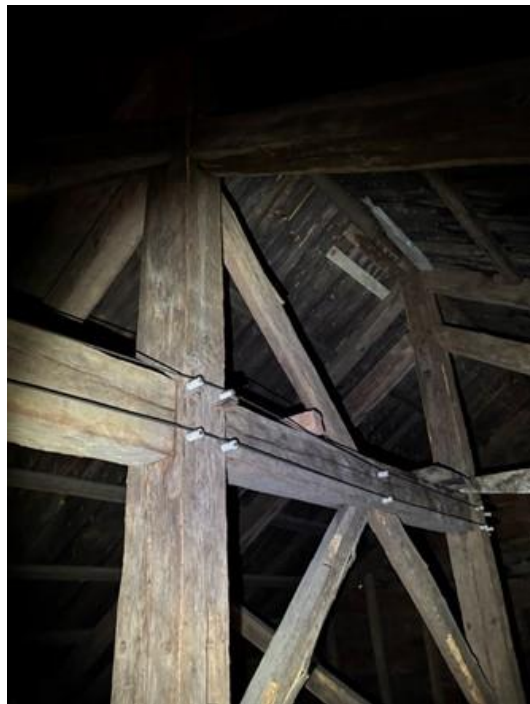
Photo 16: Missing brace in Main Truss

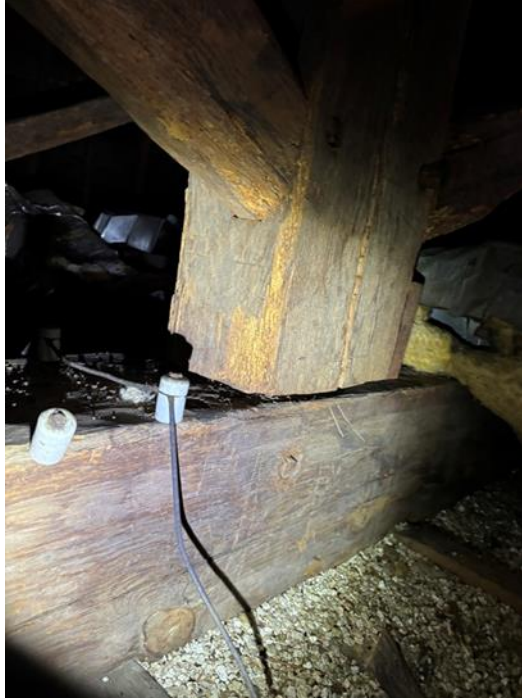
Photo 17: Powderpost beetle damage to trusswork
