Town of Londonderry CIP Committee
268B Mammoth Road - Moose Hill Council Chambers
AGENDA
August 11, 2025
6:30 PM

- I. Call To Order
- II. Approval Of Minutes From Prior Meeting

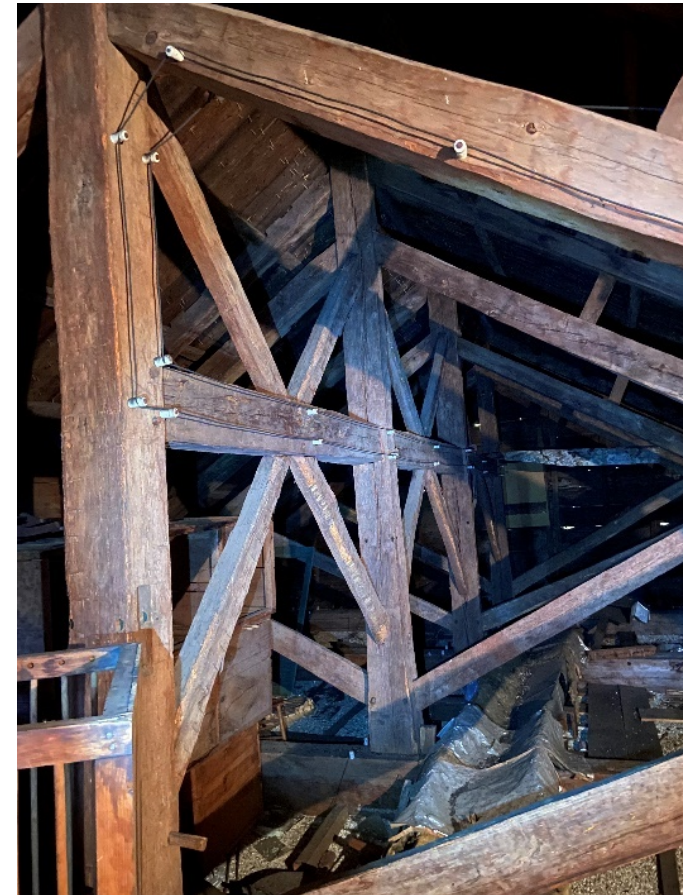
What We Found - 2022

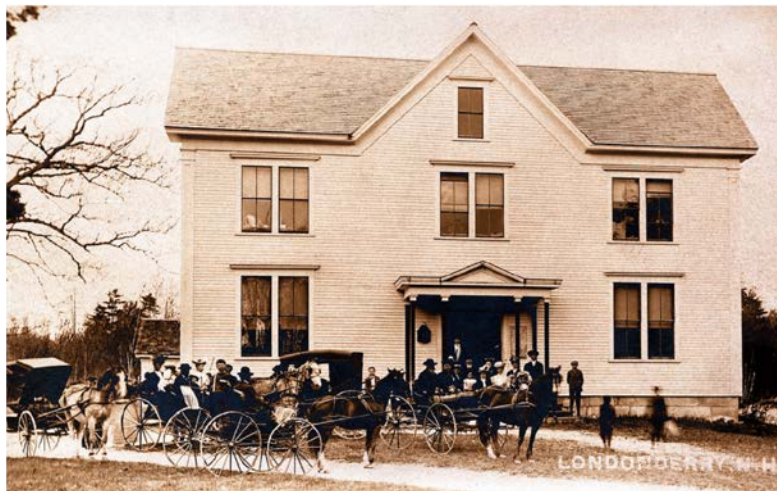
- Building Condition**
- Building Code Compliance**
- Accessibility**
- Energy Performance**

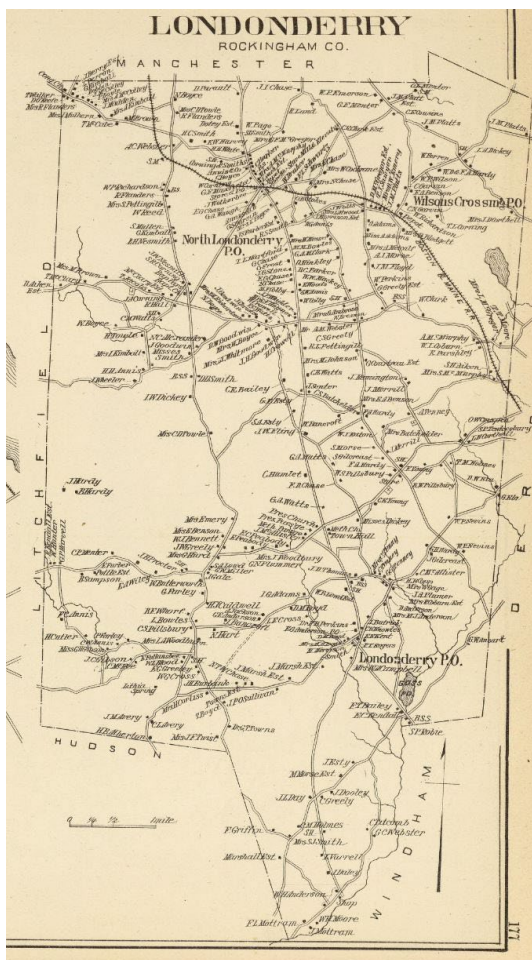
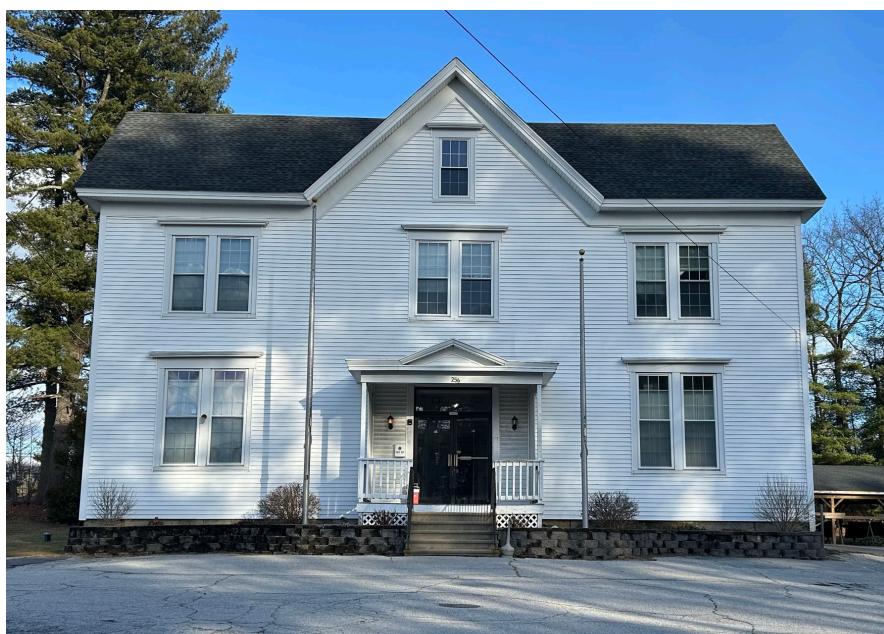
Character Defining Features

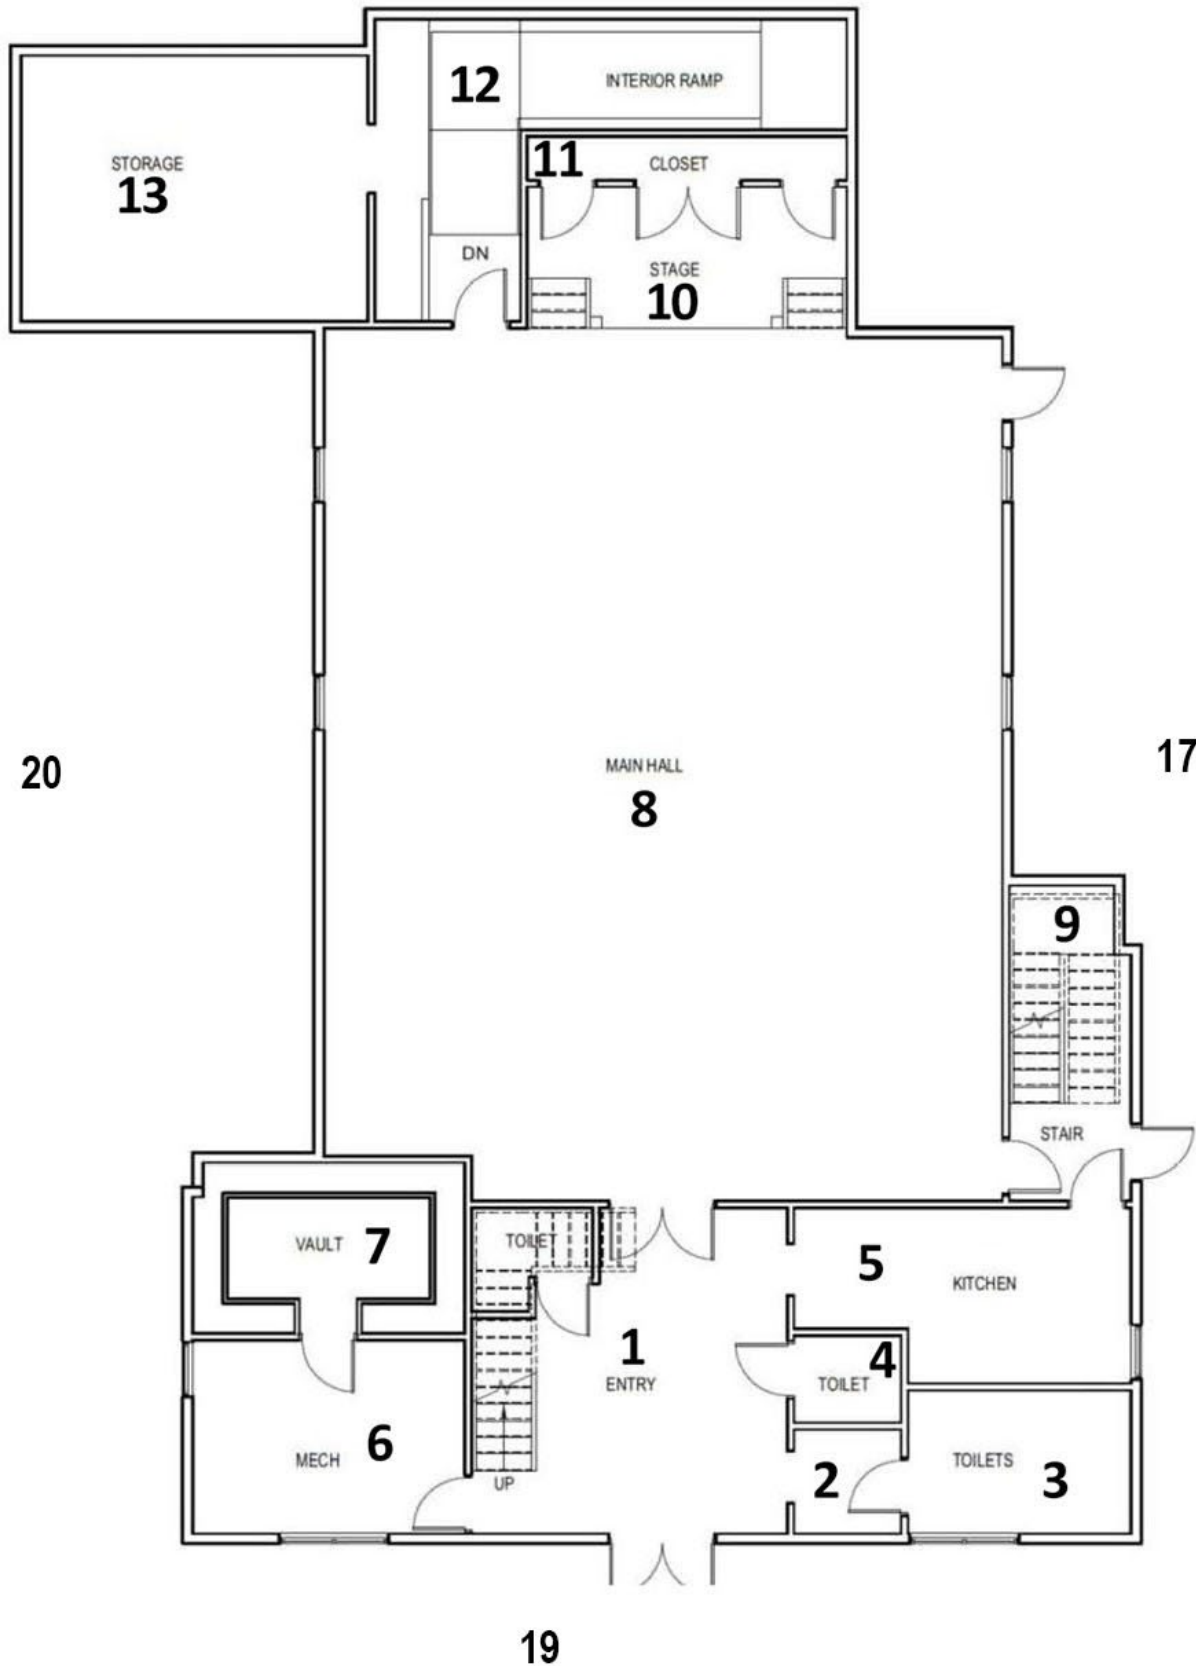
Figure 1: Floor Plans from Weston Sampson Report 2022

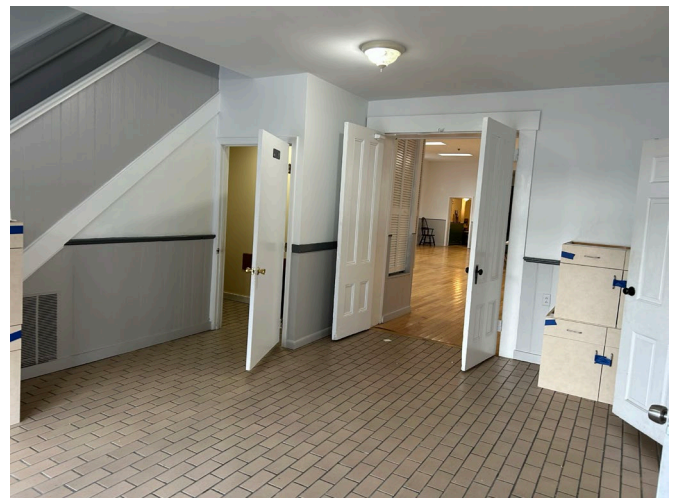
The ceiling is contemporary drywall with c. 1980s light fixtures, and smoke detectors. Similarly the walls are drywall with 1x6 flat stock door casings. The wainscot is painted bead board with chair rail, which might be original but the definition of the profile and beading is obscured by thick paint layered on over the years. The electrical outlets and switches are a mix of old and new. There is a fire alarm pull, telephone, and some emergency lighting on a shelf plugged into an outlet on the ceiling. There is forced air ventilation via ceiling and upper wall grills as well as a vent under the stair that is slightly damp and damaged.

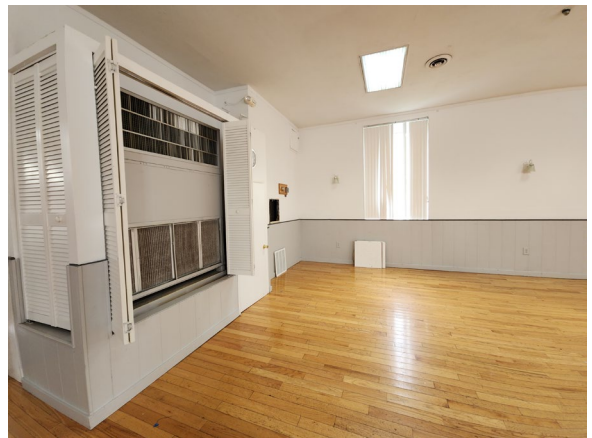
The cavity behind the modern walls near the vault shows the original walls had wood horizontal boards below a chair rail with plaster. We cannot see the original walls along the side, exterior walls without selective demolition, which will occur at a later time. The base board hovers above the floor by a couple of inches. The settlement is one inch at the rear wall. There are rodent droppings everywhere, especially at the back wall of the auditorium, kitchen, and in the vault. They probably live in the cavities of all the walls around the building. We do have some grounded outlets here and light switching, two thermostats and a timer. Transaction window to the kitchen, the oak hardwood floor looks like it has been recently refinished and is not level.

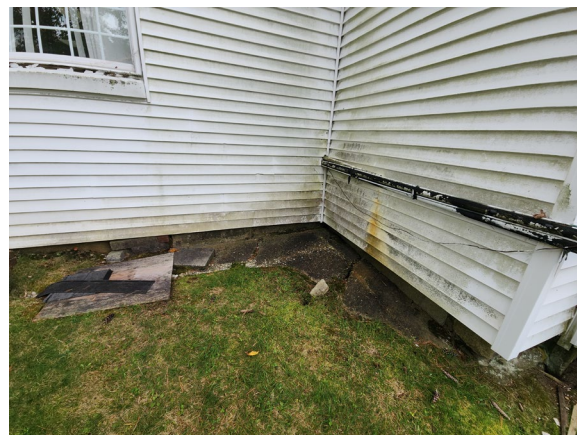
20. Northern Façade:

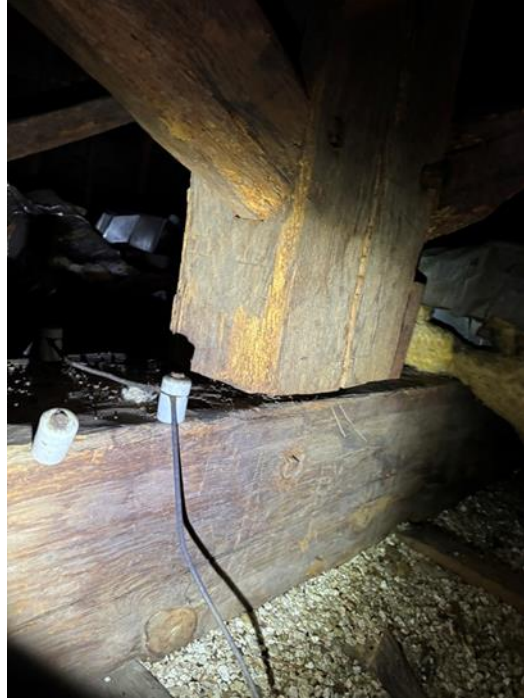
Photo 17: Powderpost beetle damage to trusswork
