## Historic Building Conditions Assessment

Reverend William Morrison Meeting House  
Londonderry, NH

May 31, 2025

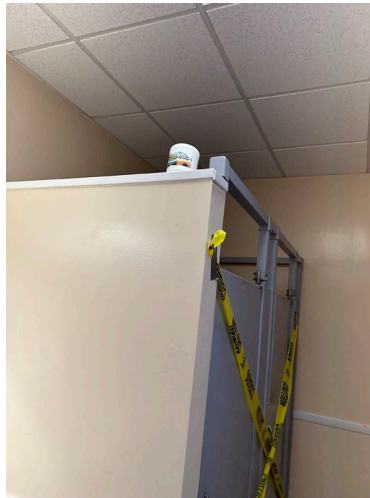
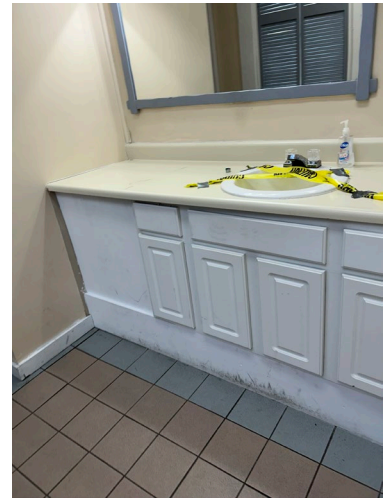
**3:** In the Women's bathroom, there are shutters on the windows, the walls are modern drywall, bathrooms are not handicap accessible. There is one sink and a solid counter below. The counter height is 37". There are two toilet stalls, not handicapped accessible, and all the plumbing is taped off with caution tape for winter. The millwork under the sink counter, is all circa 1980s and it's contoured plastic laminate countertop with the MDF prefab door panels, which are mounted crooked. In poor condition, there is a CT ceiling emergency lighting, ceiling vents, and large 2x4 fluorescent light fixture, the painted wood shutters on the windows don't open as they are screwed shut.

- a. New layout, fixtures, and door hardware/thresholds are required for handicap accessibility. Expansion into the kitchen area may be required. The kitchen could be relocated to the Storage space north of stage (#13 on plan) if that area was to be insulated and weatherproofed. The remaining remnants of historic wood wainscot should be repaired and preserved where possible.

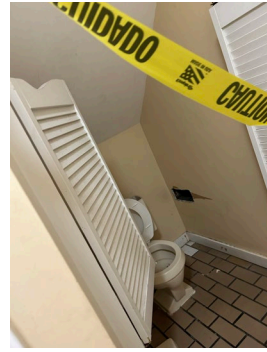
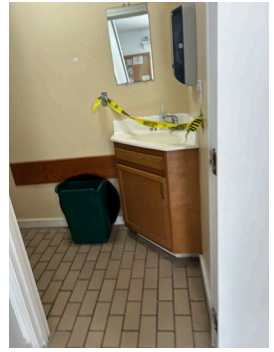
4.5: The men's bathroom under the stair is not ADA accessible, and has a saloon style stall.

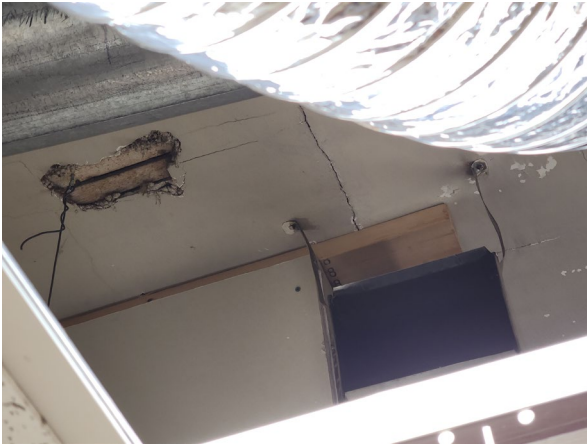
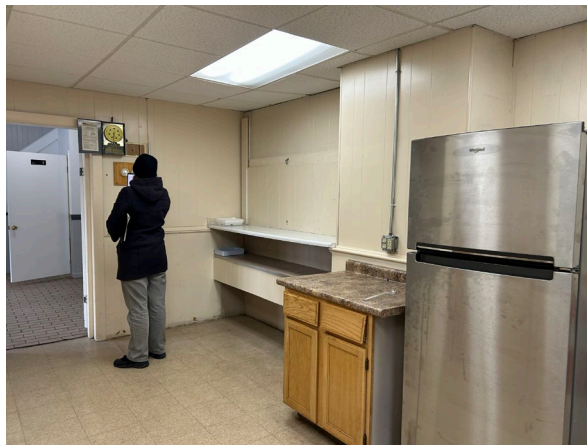
5: The kitchen is VCT 12x12 flooring, possibly c. 1980s plastic laminate. The countertops are chipped, warped, and crooked. The ceiling tiles are not in poor condition however, there is approx. 4-5' above the ACT ceiling, up to the original ceiling, which is lath on plaster. Some of the plaster is missing, and the lath on plaster that remains is terribly cracked. ACT ceiling has 2x4 lights. There is a small hot water tank underneath the microwave next to the window that is roughly 10 gallons.

There is a refrigerator, fire extinguisher, surface mounted conduits, two quadruplex receptacle outlets, 70's era wood paneling, which has been painted on the walls. On the wall next to the door is a Dayton seven day dial, time switch, four pole, two normally open, two normally closed, and model number 2E21. The paneling seems original before paint.

5: Kitchen: Finishes are worn throughout, some in poor condition – especially the ceiling. See #3 above for Kitchen relocation suggestion.

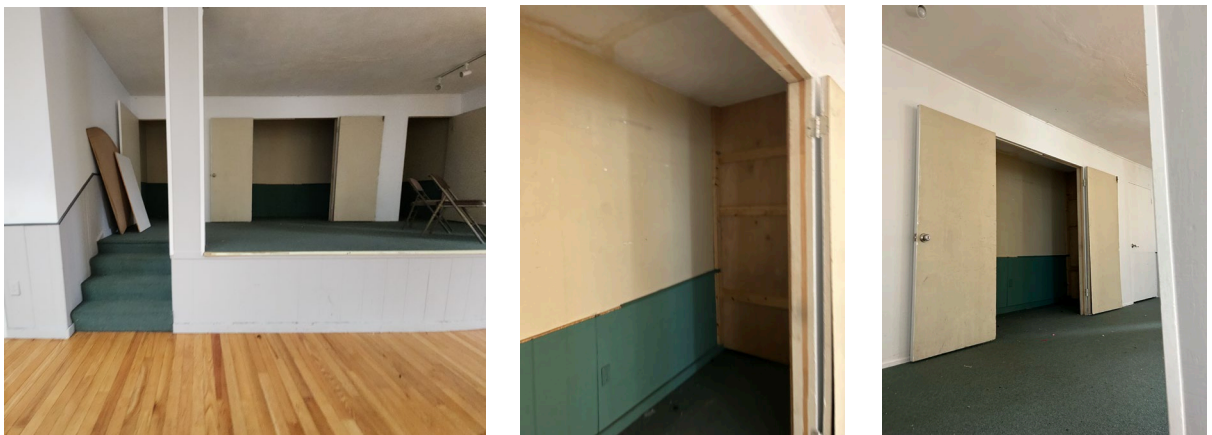
**10 & 11:** The exit door from the stage to the outside has very old panic hardware and closer, and is in need of refurbishment. There's an exit sign above, emergency lighting, fire alarm, station, fire extinguisher. There is a stage platform with steps on either side, which has c. 1980s paneling, textured plaster, ceiling on drywall. There is some circa 1980's track lighting, and worn green carpeting in poor condition. There is another 100 amp electrical panel, stage left, which is not labeled.

There does appear to be some water damage at the ceiling above the stage that worsens when inside of the closet behind the stage. The height of the stage platform is 32" above the auditorium and there are no proper handrails.

- a. The exit door from the stage to the exterior requires weatherstripping and new code compliant exit hardware.
- b. Stage finishes and lighting are not historically significant, they are functional but worn, and would benefit from updates.
- c. Repair ceiling and roof flashing at location of visible water damage above the stage and backstage
- d. Handrails should be installed at the side stage steps.

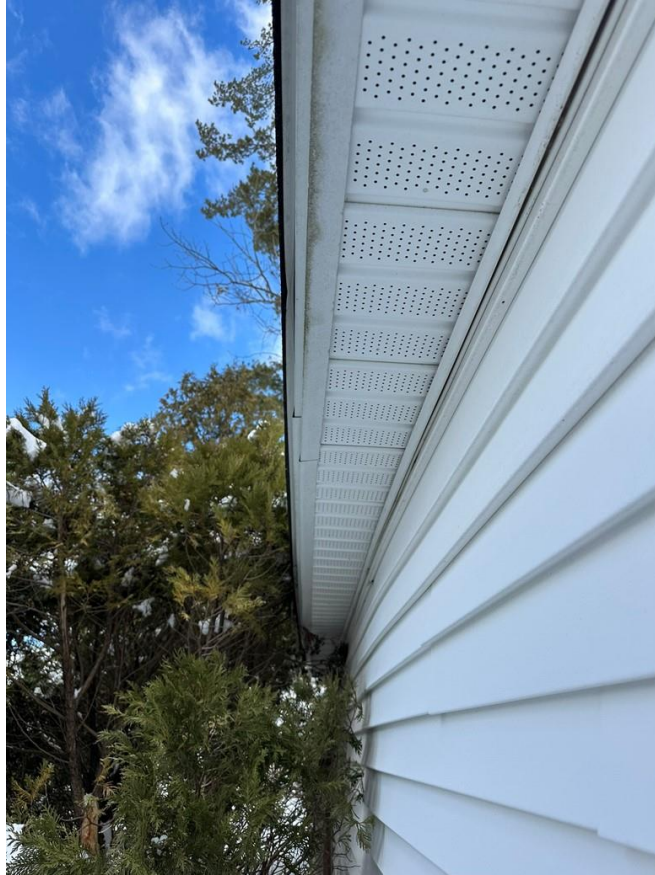
Photo 1: Outward bow in gutter of Side Room

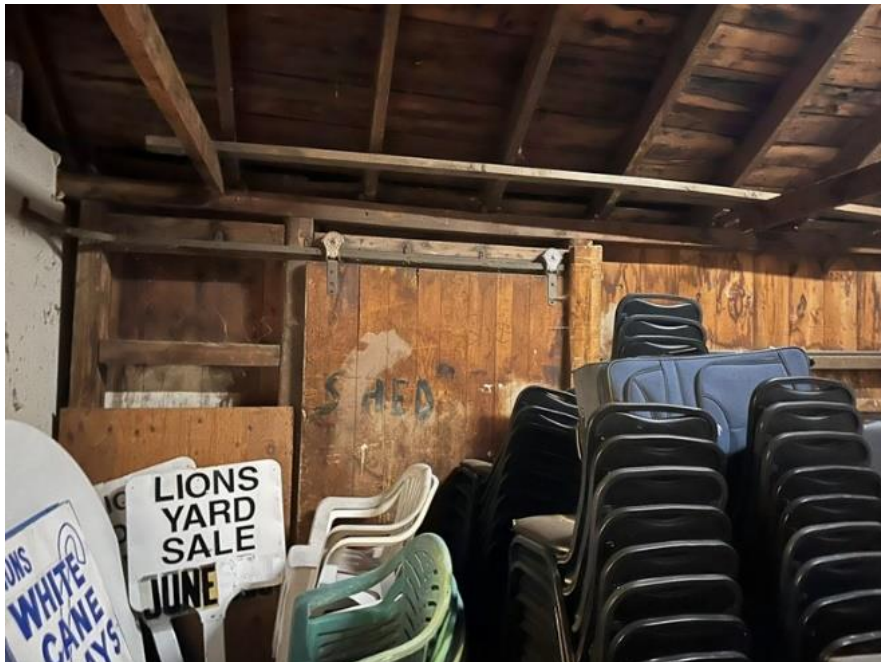
Photo 2: Deflection in Wall Plate of Side Room

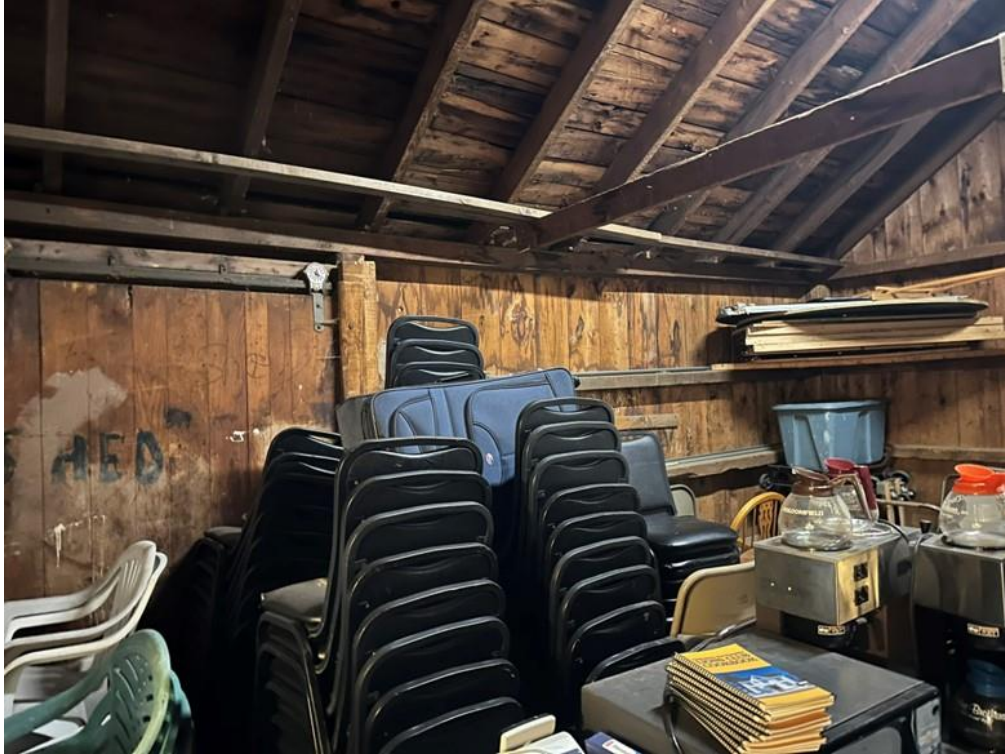
Photo 3: Deflection in Wall Plate of Side Room

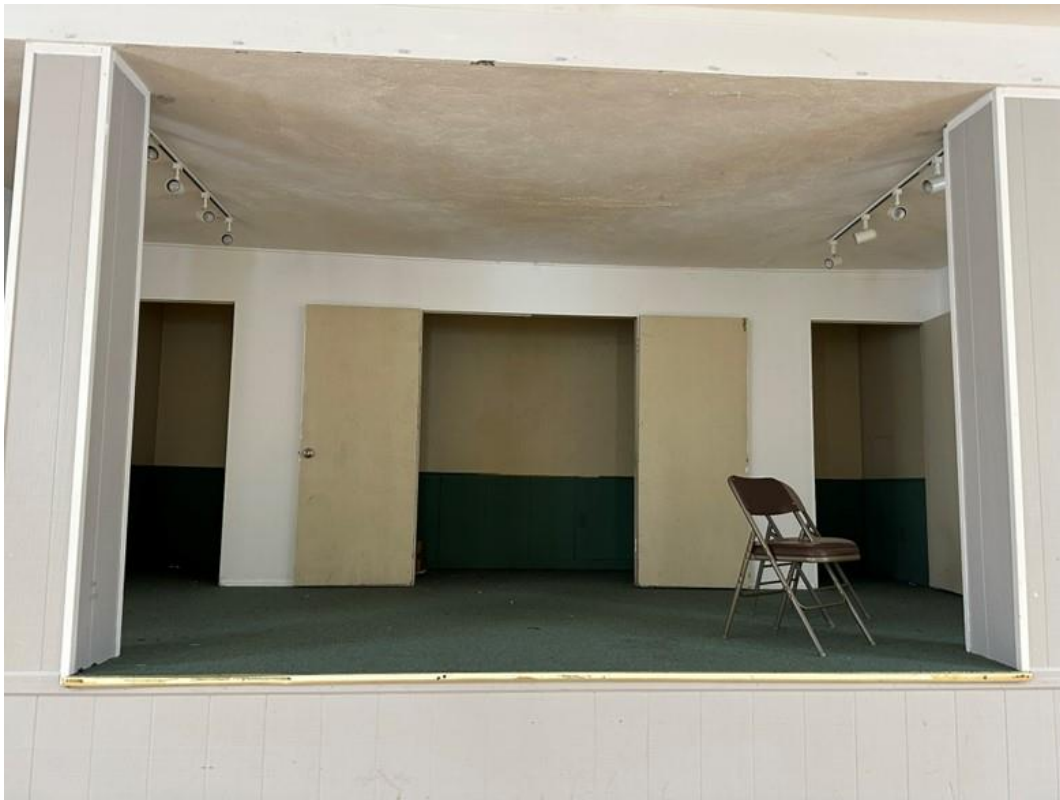
Photo 4: Deflection in Stage Ceiling

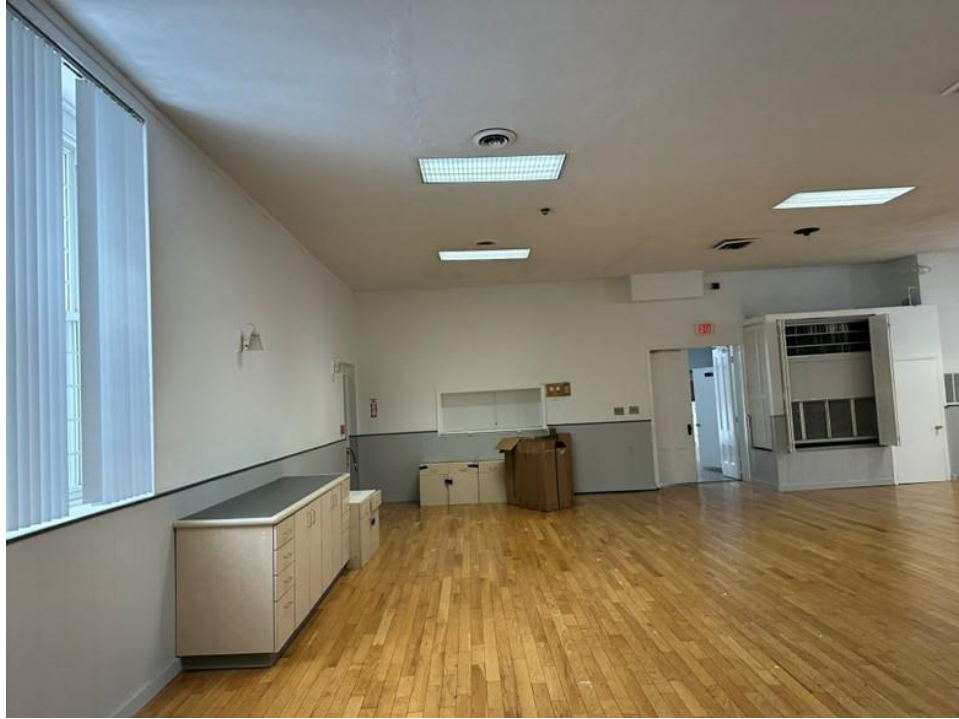
Photo 5: Floor deflection

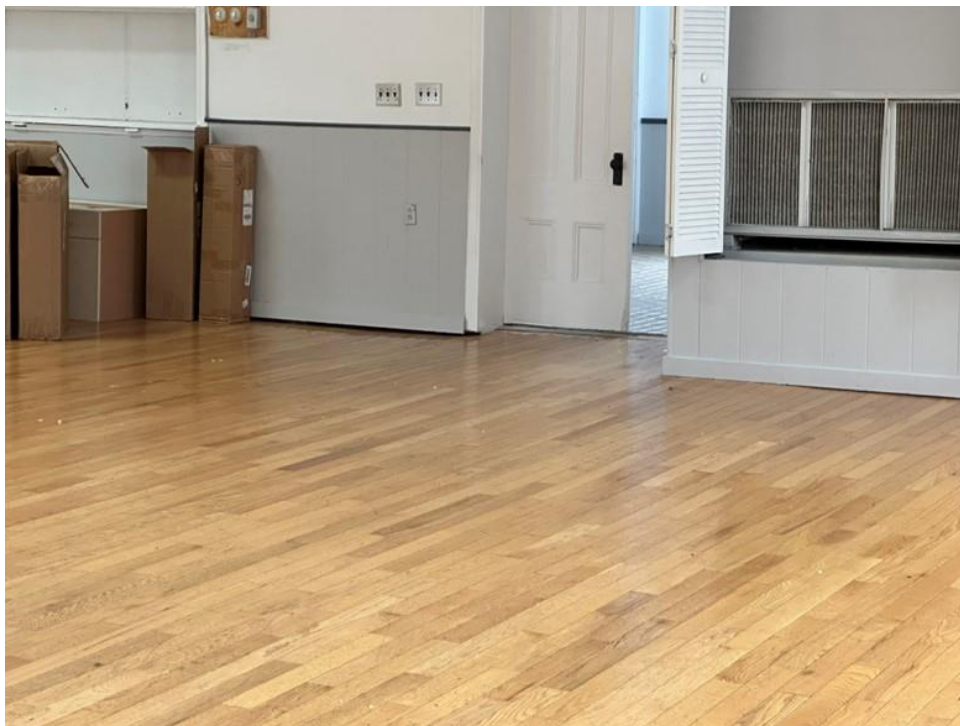
Photo 6: Deflection in Main Room Floor

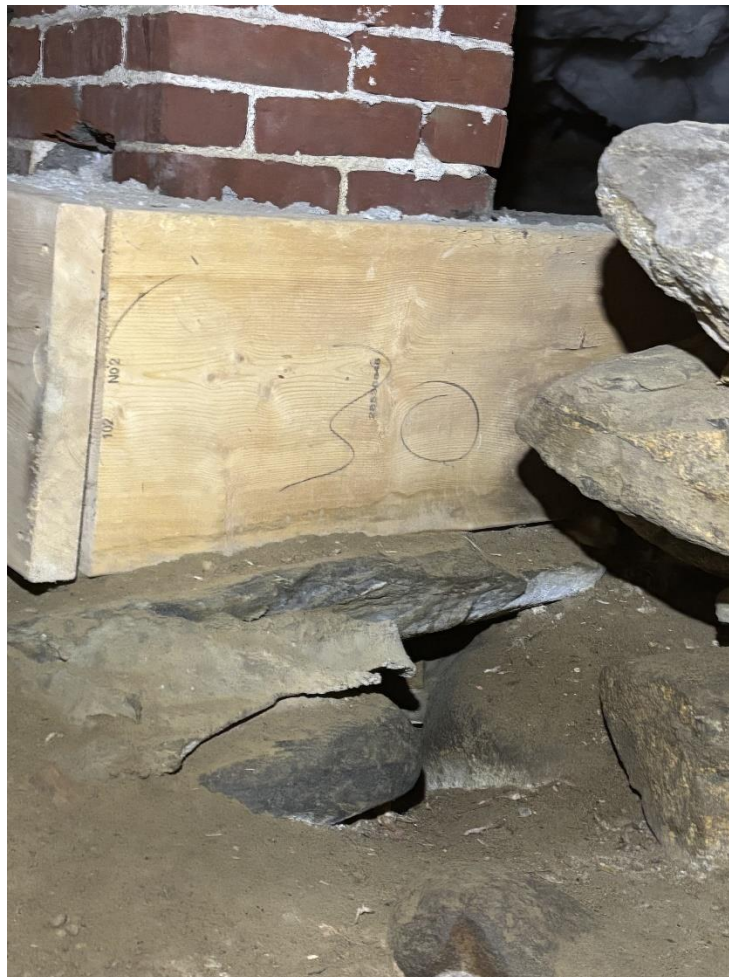
Photo 8: Burrow below pier

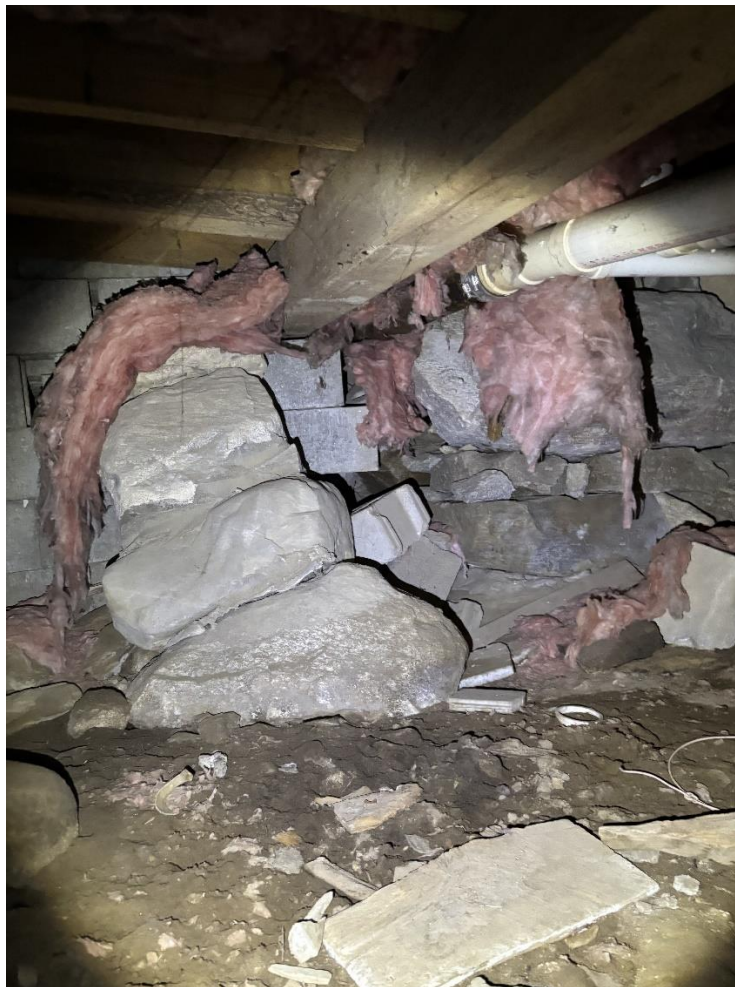
Photo 10: Beam bearing on CMU

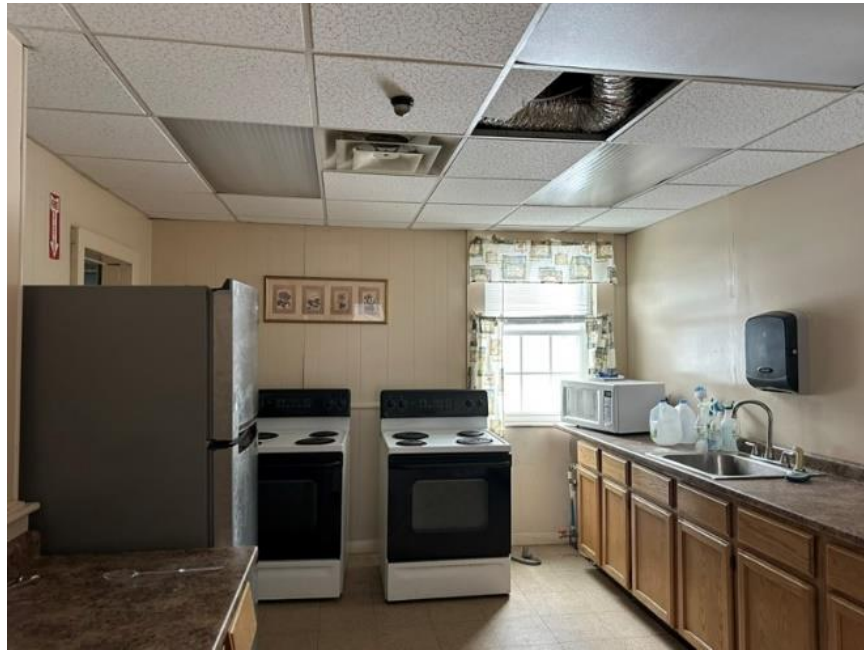
Photo 11: Deflection in Kitchen Ceiling

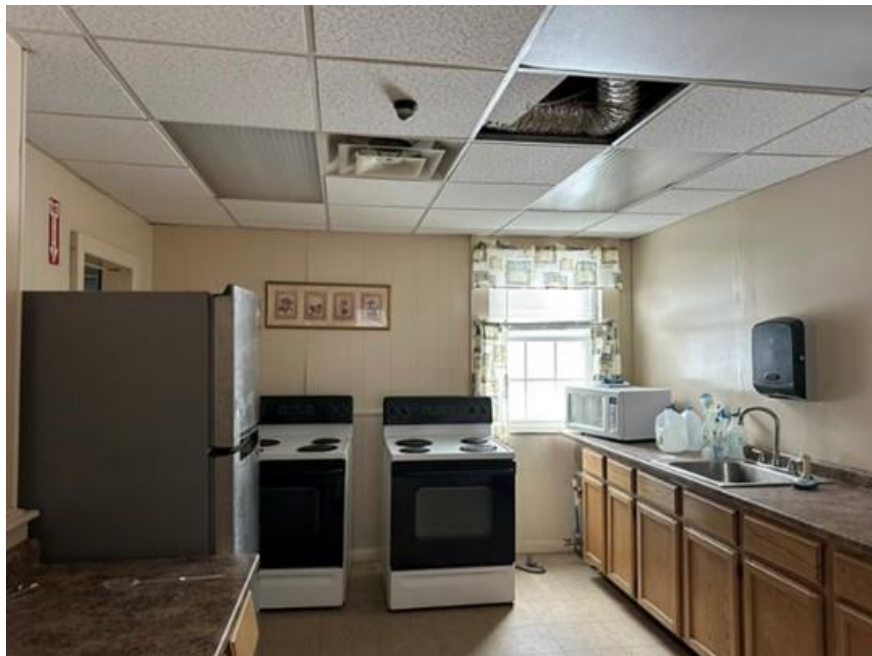
Photo 12: Deflection in Kitchen Ceiling

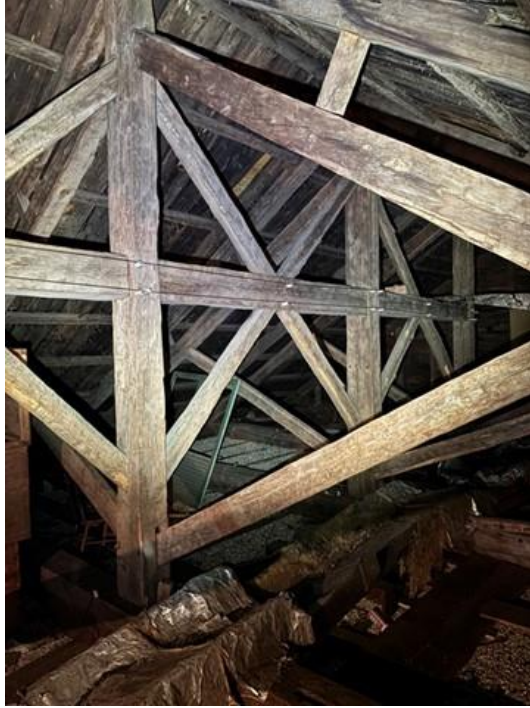
Photo 15: Missing brace in Main Truss

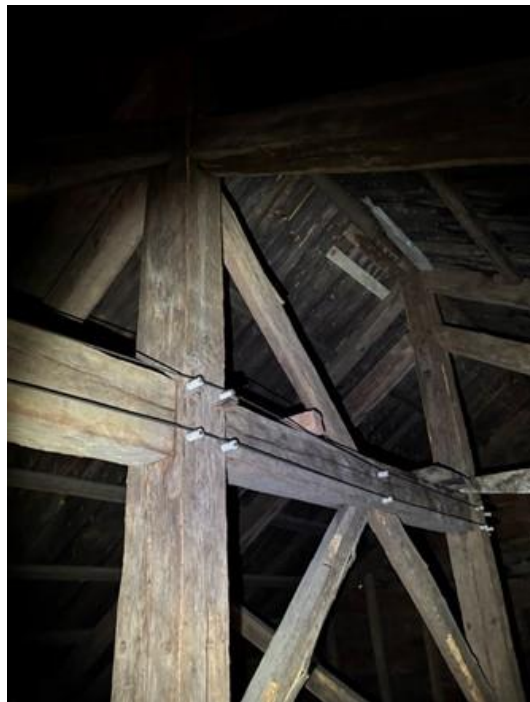
Photo 16: Missing brace in Main Truss
