Town of Londonderry CIP Committee
268B Mammoth Road - Moose Hill Council Chambers
AGENDA
August 11, 2025
6:30 PM

Historic Building Conditions Assessment

Reverend William Morrison Meeting House
Londonderry, NH

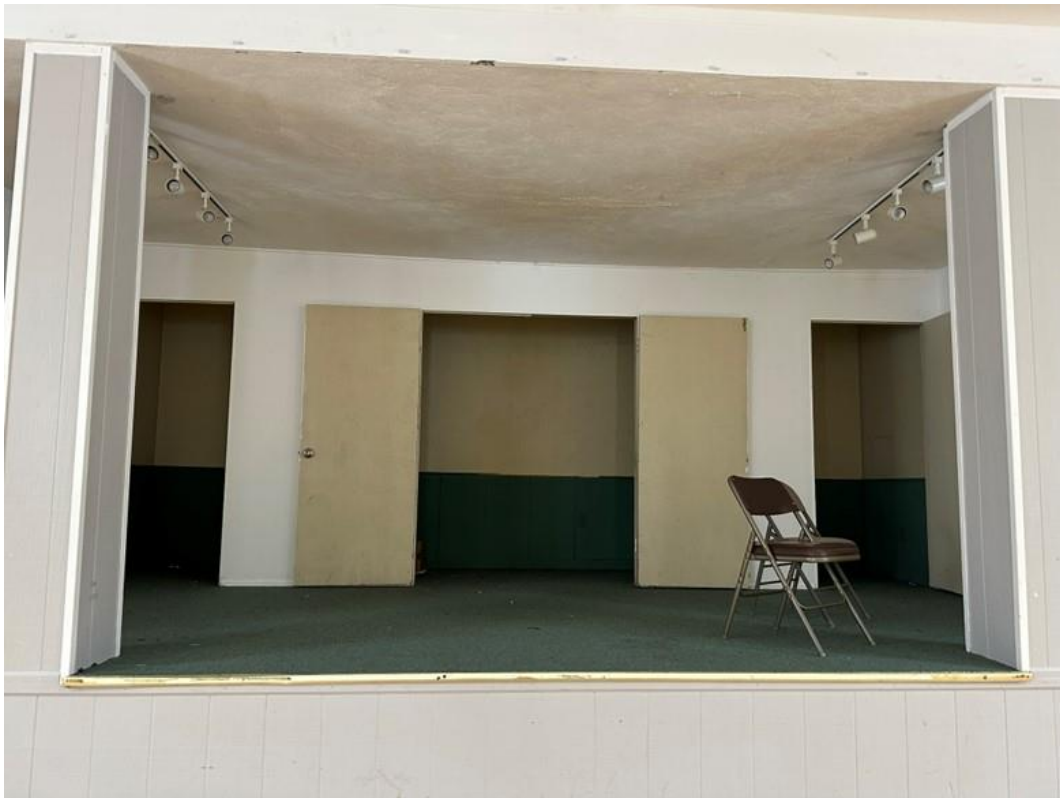
Photo 4: Deflection in Stage Ceiling

- The stage floor and ceiling slope backwards (as shown in Photo 4) *and should be investigated as to why*. Some of this may be due to foundation settlement.
- The east and west walls of the small ell consist of closed off door openings that are spanned by a top eave level wall plates, at least one of which sags (shown in Photos 2 and 3). *All of the spanning plates should be sistered with ripped LVLs.*
- The roof eaves are held in place by only one single 2x6 collar tie to keep them from spreading apart (See Photo 1). *At least two additional collar ties should be added and the end-nailing on the existing tie should be increased.*

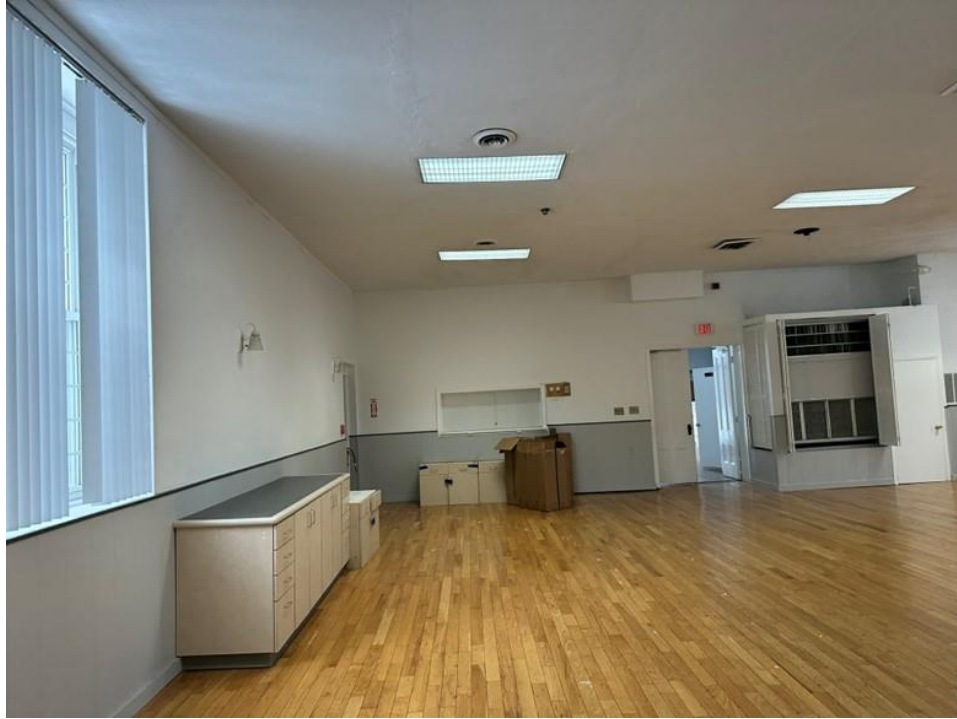
Photo 5: Floor deflection

- In the large hall there is noticeable deflection and undulation in the floor. Some of this is due to normal deflection of the joists between the supporting timber beams, however in the center of the space there is a concentrated depression of several inches (See Photos 5 & 6).
