**Town of Londonderry CIP Committee**  
**268B Mammoth Road - Moose Hill Council Chambers**  
**AGENDA**  
**August 11, 2025**  
**6:30 PM**

## Historic Building Conditions Assessment

Reverend William Morrison Meeting House  
Londonderry, NH

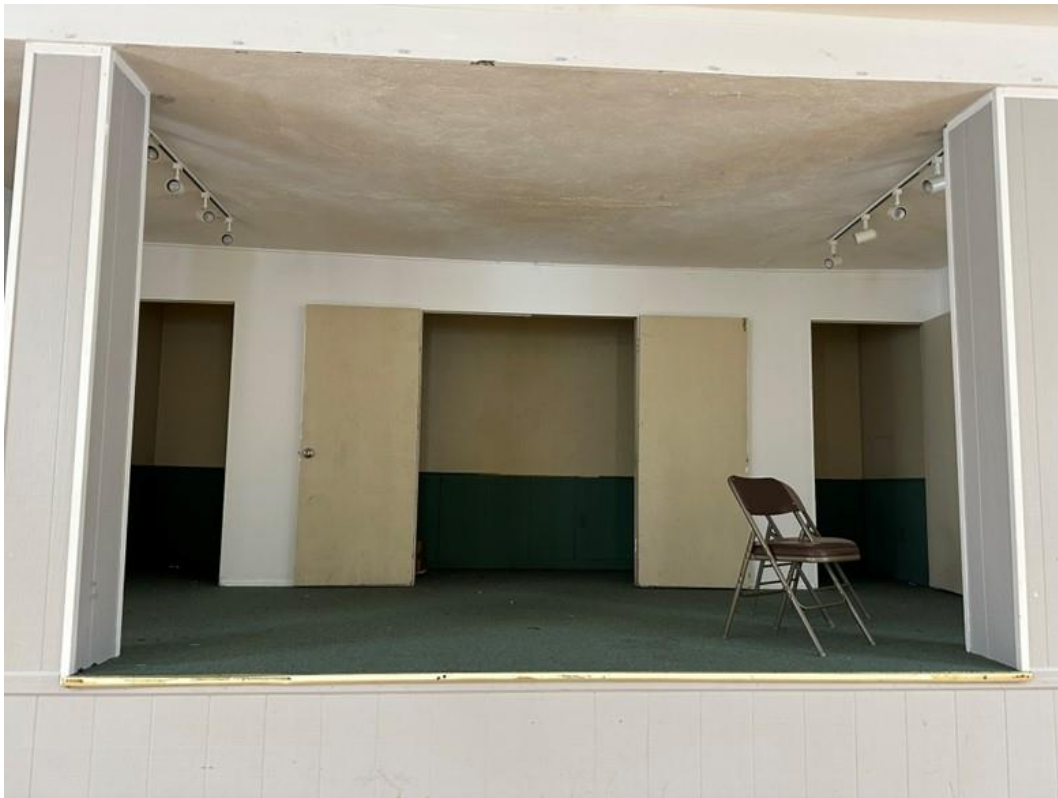
- The stage floor and ceiling slope backwards (as shown in Photo 4) *and should be investigated as to why*. Some of this may be due to foundation settlement.
- The east and west walls of the small ell consist of closed off door openings that are spanned by a top eave level wall plates, at least one of which sags (shown in Photos 2 and 3). *All of the spanning plates should be sistered with ripped LVLs.*
- The roof eaves are held in place by only one single 2x6 collar tie to keep them from spreading apart (See Photo 1). *At least two additional collar ties should be added and the end-nailing on the existing tie should be increased.*

Photo 3: Deflection in Wall Plate of Side Room

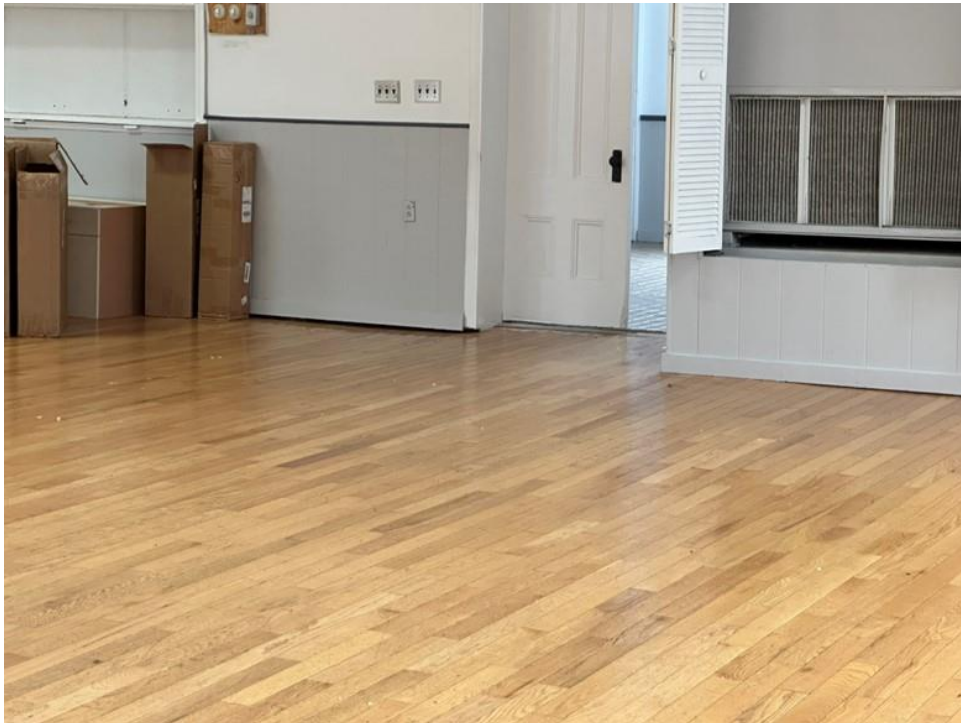
- In the large hall there is noticeable deflection and undulation in the floor. Some of this is due to normal deflection of the joists between the supporting timber beams, however in the center of the space there is a concentrated depression of several inches (See Photos 5 & 6).

Photo 5: Floor deflection

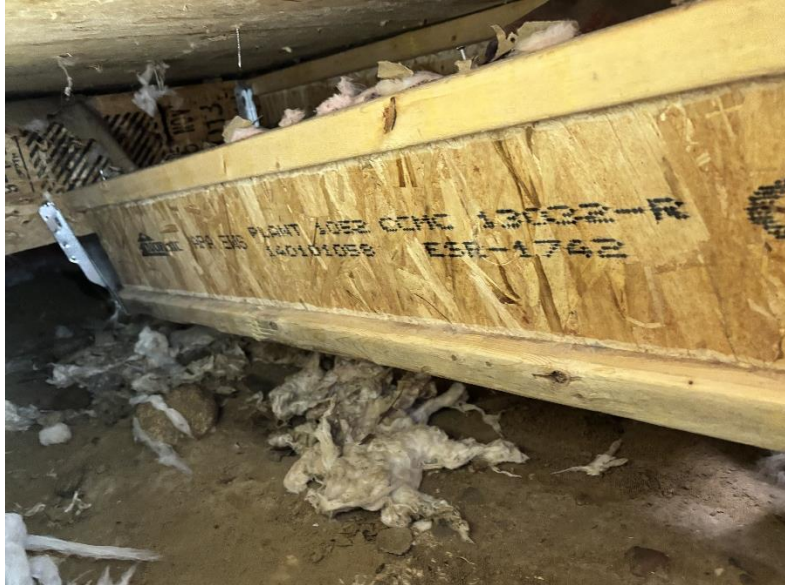
The I-joists below the depression were supported at one end with hangers that only had one nail per flange and were fastened to an LSL (laminated strand lumber) nailer that had been lightly nailed to the original supporting timber. The joist hanger sheared off of the LSL, causing the joist end to drop by more than an inch (See Photo 7). In addition, the LSL nailer appeared to have slipped vertically downward on the face of the original timber, mostly due to the fact that there were too few nails connection the nailer and the surface of the timber was too rounded and uneven to effectively nail onto. As a result, the I-joist floor framing, which we confirmed to be sufficiently sized for the load and span, are not are not sufficiently connected at their ends to reach the full design loading without the ends shearing off. Given the noted undulation of the floor, it is quite possible that this insufficient connection condition exists throughout the main hall’s floor.

Photo 6: Deflection in Main Room Floor

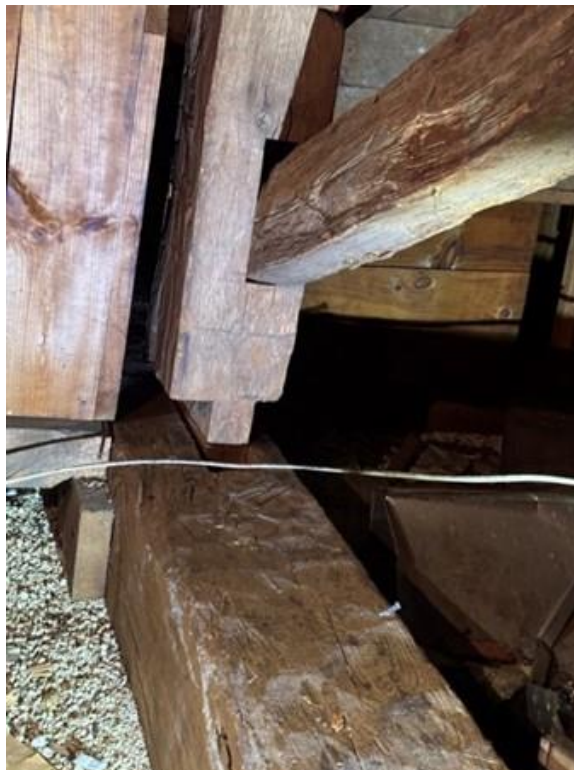
- We noted several notches and mortises and unused mortices in the truss timbers in the attic, suggesting that some of the framing members were either salvaged and repurposed, modified or mis-cut (Photo 13). In addition, several of

Photo 13: Multiple open notches throughout Main Truss chords
