## Historic Building Conditions Assessment

Reverend William Morrison Meeting House  
Londonderry, NH

May 31, 2025

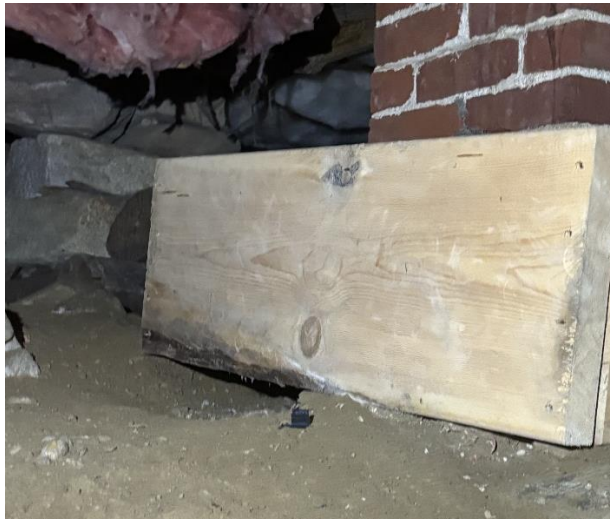
Photo 9: Burrow below pier

- From what we could access, the visible timber and sill conditions looked satisfactory, however, there is a lot of insulation blocking our view.
- There are several animal burrows in the crawlspace, one of which has been dug directly underneath a brick pier that may want to settle as a result (See Photos 8 and 9). *We recommend that a rodent control inspection and abatement program gets set in place, which may include flushing with water evacuate the rodents or dry ice. The borrow beneath the structural pier should be filled with grout. Afterwards, a Hardware Cloth should be installed over or just below the crawlspace ground surface.*

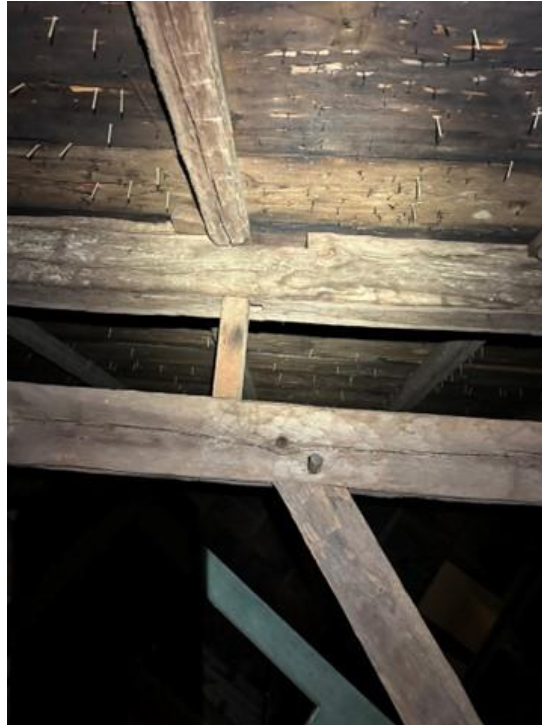
Photo 13: Multiple open notches throughout Main Truss chords

- We noted several notches and mortises and unused mortices in the truss timbers in the attic, suggesting that some of the framing members were either salvaged and repurposed, modified or mis-cut (Photo 13). In addition, several of
